# Access Compliance Report
Public Rights-of-Way
(Curb Ramps)

Intersection ID: 11114	Main Street: AVENSONG_CROSSING_DR	Cross Street: CAMP_STEWART_RD	Location:	SW
ADA ID: A2DB6ECC1008	Ramp Type: Perp	Initial Pass/Fail: Fail	Overall Compliance: No	Severity Score: 33.75

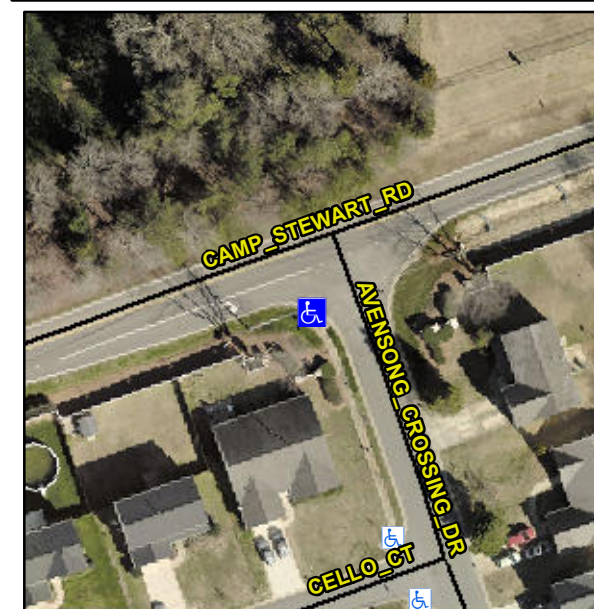
Not Found, R304.5.1, R304.5.3

Compliance	Description	Data	Compliance	Description	Data
N/A	Ramp Length (in)	46.5	Yes	Ramp Slope (%)	6.5
No	Ramp Width (in)	44.5	No	Ramp XSlope (%)	8.0
N/A	Flare Type LT	N/A	N/A	Flare Type RT	N/A
N/A	Flare Slope LT (%)	N/A	N/A	Flare Slope RT (%)	N/A
N/A	Flare Traversable LT?	N/A	N/A	Flare Traversable RT?	N/A
N/A	Landing Length (in)	N/A	N/A	DWS Provided?	N/A
N/A	Landing Width (in)	N/A	N/A	DWS Contrast?	N/A
N/A	Landing Slope (%)	N/A	N/A	DWS Length (in)	N/A
N/A	Landing X Slope (%)	N/A	N/A	DWS Full Width?	N/A
N/A	Landing Curb? (Y/N)	N/A	N/A	DWS Offset (in)	N/A
N/A	Shared Landing?	N/A			
N/A	Gutter Ponding?	N/A	N/A	Gutter Slope (%)	N/A
N/A	Gutter Lip Ht (in)	N/A	N/A	Gutter X Slope (%)	N/A
N/A	Painted X Walk1?	No	N/A	Painted X Walk2?	N/A
	X Walk 1 Direction	To N		X Walk 2 Direction	N/A
N/A	X Walk 1 Width (in)	N/A	N/A	X Walk 2 Width (in)	N/A
	X Walk 1 Slope (%)	0.1		X Walk 2 Slope (%)	N/A
	X Walk 1 X Slope (%)	0.1		X Walk 2 X Slope (%)	N/A

Remove & Replace Entire Ramp.
