Access Compliance Report
Public Rights-of-Way
(Curb Ramps)

Intersection ID: 50326	**Main Street:** THOREAU_CT	**Cross Street:** SHARPES_CR	**Location:**	**SW**
ADA ID: A31F327DBE16	**Ramp Type:** PerpDiag	**Initial Pass/Fail:** Fail	**Overall Compliance:** No	**Severity Score:** 25

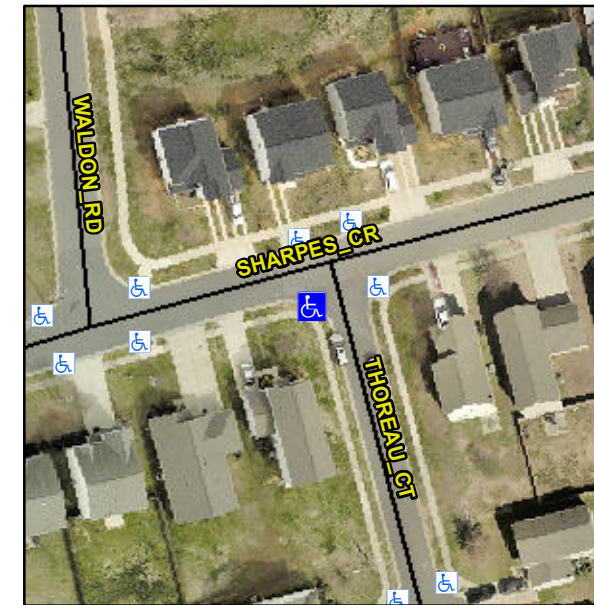
Not Found, R304.5.3

Compliance	Description	Data	Compliance	Description	Data
N/A	Ramp Length (in)	47.5	Yes	Ramp Slope (%)	6.4
Yes	Ramp Width (in)	48.0	No	Ramp XSlope (%)	7.1
N/A	Flare Type LT	N/A	N/A	Flare Type RT	N/A
N/A	Flare Slope LT (%)	N/A	N/A	Flare Slope RT (%)	N/A
N/A	Flare Traversable LT?	N/A	N/A	Flare Traversable RT?	N/A
N/A	Landing Length (in)	N/A	N/A	DWS Provided?	N/A
N/A	Landing Width (in)	N/A	N/A	DWS Contrast?	N/A
N/A	Landing Slope (%)	N/A	N/A	DWS Length (in)	N/A
N/A	Landing X Slope (%)	N/A	N/A	DWS Full Width?	N/A
N/A	Landing Curb? (Y/N)	N/A	N/A	DWS Offset (in)	N/A
N/A	Shared Landing?	N/A			
N/A	Gutter Ponding?	N/A	N/A	Gutter Slope (%)	N/A
N/A	Gutter Lip Ht (in)	N/A	N/A	Gutter X Slope (%)	N/A
N/A	Painted X Walk1?	No	N/A	Painted X Walk2?	No
	X Walk 1 Direction	To E		X Walk 2 Direction	To N
N/A	X Walk 1 Width (in)	N/A	N/A	X Walk 2 Width (in)	N/A
	X Walk 1 Slope (%)	0.7		X Walk 2 Slope (%)	6.4
	X Walk 1 X Slope (%)	5.2		X Walk 2 X Slope (%)	2.1

Remove & Replace Curb Ramp With Two New Directional Ramps or Equivalent.
