Access Compliance Report

# Public Rights-of-Way
(Curb Ramps)

Intersection ID: 12991	Main Street: E_MOREHEAD_ST	Cross Street: S_TRYON_ST	Location: N
ADA ID: A3A5713BC0D6	Ramp Type: PerpDiag	Initial Pass/Fail: Fail	Overall Compliance: No	Severity Score: 21.25

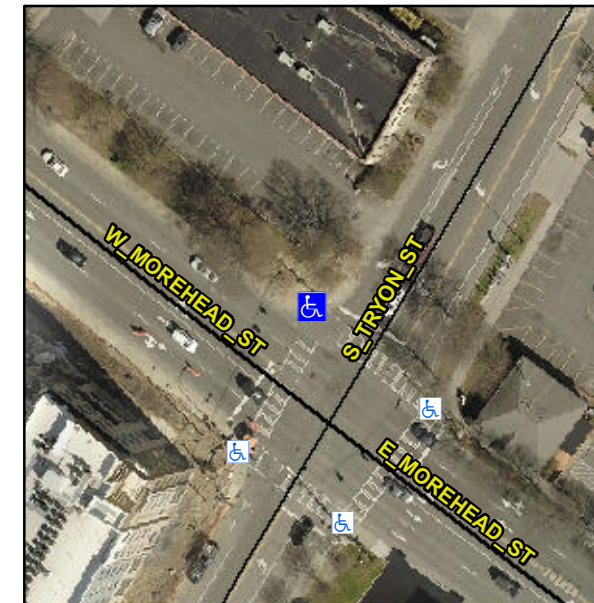
Not Found, R304.5.1, R304.2.2

Compliance	Description	Data	Compliance	Description	Data
N/A	Ramp Length (in)	60.0	No	Ramp Slope (%)	10.8
No	Ramp Width (in)	45.0	Yes	Ramp XSlope (%)	0.8
N/A	Flare Type LT	N/A	N/A	Flare Type RT	N/A
N/A	Flare Slope LT (%)	N/A	N/A	Flare Slope RT (%)	N/A
N/A	Flare Traversable LT?	N/A	N/A	Flare Traversable RT?	N/A
N/A	Landing Length (in)	N/A	N/A	DWS Provided?	N/A
N/A	Landing Width (in)	N/A	N/A	DWS Contrast?	N/A
N/A	Landing Slope (%)	N/A	N/A	DWS Length (in)	N/A
N/A	Landing X Slope (%)	N/A	N/A	DWS Full Width?	N/A
N/A	Landing Curb? (Y/N)	N/A	N/A	DWS Offset (in)	N/A
N/A	Shared Landing?	N/A			
N/A	Gutter Ponding?	N/A	N/A	Gutter Slope (%)	N/A
N/A	Gutter Lip Ht (in)	N/A	N/A	Gutter X Slope (%)	N/A
N/A	Painted X Walk1?	Yes	N/A	Painted X Walk2?	Yes
	X Walk 1 Direction	To SW		X Walk 2 Direction	To SE
N/A	X Walk 1 Width (in)	112.0	N/A	X Walk 2 Width (in)	111.0
	X Walk 1 Slope (%)	4.9		X Walk 2 Slope (%)	2.7
	X Walk 1 X Slope (%)	2.0		X Walk 2 X Slope (%)	3.5

Remove & Replace Curb Ramp With Two New Directional Ramps or Equivalent.
