Access Compliance Report
Public Rights-of-Way
(Curb Ramps)

Intersection ID: 10016341	**Main Street: UNIVERSITY_CITY_BV**	**Cross Street: N/A**	**Location: SW**
ADA ID: A3D64BBE548C	**Ramp Type: Perp**	**Initial Pass/Fail: Pass** **Overall Compliance: No**	**Severity Score: 2.5**

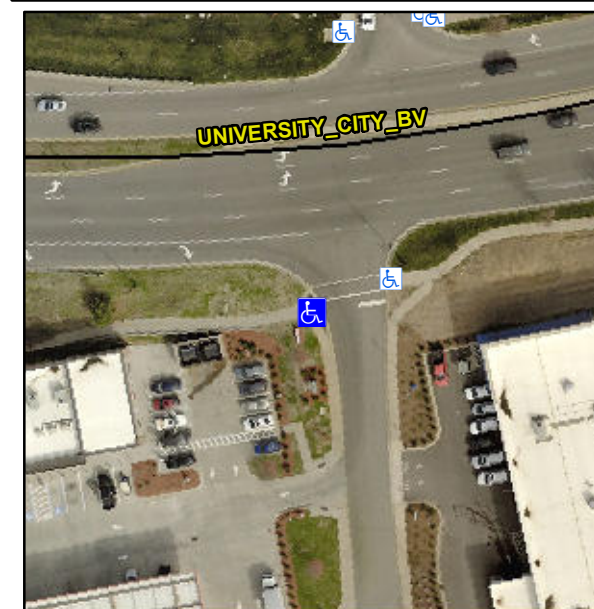
Compliance	Description	Data	Compliance	Description	Data
N/A	Ramp Length (in)	76.0	Yes	Ramp Slope (%)	5.7
Yes	Ramp Width (in)	68.0	Yes	Ramp XSlope (%)	1.1
Yes	Flare Type LT Curbed_NoWalkSurface		Yes	Flare Type RT	N/A
Yes	Flare Slope LT (%)	N/A	N/A	Flare Slope RT (%)	N/A
N/A	Flare Traversable LT?	No	N/A	Flare Traversable RT?	No
Yes	Landing Length (in)	58.0	Yes	DWS Provided?	Yes
Yes	Landing Width (in)	58.0	Yes	DWS Contrast?	Yes
Yes	Landing Slope (%)	0.3	Yes	DWS Length (in)	25.0
Yes	Landing X Slope (%)	0.1	No	DWS Full Width?	No
N/A	Landing Curb? (Y/N)	No	Yes	DWS Offset (in)	1.5
N/A	Shared Landing?	No			
Yes	Gutter Ponding?	No	Yes	Gutter Slope (%)	0.2
Yes	Gutter Lip Ht (in)	0.0	Yes	Gutter X Slope (%)	0.3
N/A	Painted X Walk1?	Yes	N/A	Painted X Walk2?	N/A
	X Walk 1 Direction	To E		X Walk 2 Direction	N/A
N/A	X Walk 1 Width (in)	89.0	N/A	X Walk 2 Width (in)	N/A
	X Walk 1 Slope (%)	1.6		X Walk 2 Slope (%)	N/A
	X Walk 1 X Slope (%)	0.1		X Walk 2 X Slope (%)	N/A

Yes	Ramp inside XWalk1?	Yes	N/A	Ramp inside XWalk2?	N/A
	Road Slope (%)	N/A	N/A	Clear Space?	Yes
	Road X Slope (%)	N/A	N/A	Clear Space to XWalk (in)	N/A
Yes	Any Obstructions?	No	Yes	Storm Grate/Utility Hazard?	No
	Obstruction Type			Storm Grate/Utility Type	
		N/A			N/A
			Yes	Surface Condition? (G/P)	Good

Remove & Replace Detectable Warning System.

R305.1.4
