Access Compliance Report
Public Rights-of-Way
(Curb Ramps)

Intersection ID: 10015635	Main Street: HARRIS_CORNERS_PY	Cross Street: N/A		Location:	N
ADA ID: A3DBA5F48193	Ramp Type: BlendTrans2	Initial Pass/Fail: Fail	Overall Compliance: No	Severity Score:	8.75

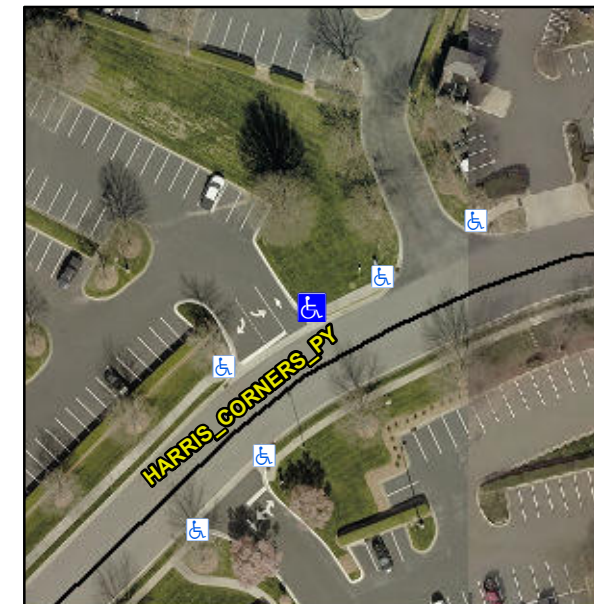
R304.5.1

Compliance	Description	Data	Compliance	Description	Data
N/A	Ramp Length (in)	59.0	Yes	BlendTrans Slope (%)	0.4
No	Ramp Width (in)	40.0	Yes	BlendTrans XSlope (%)	1.9
N/A	Flare Type LT	N/A	N/A	Flare Type RT	N/A
N/A	Flare Slope LT (%)	N/A	N/A	Flare Slope RT (%)	N/A
N/A	Flare Traversable LT?	N/A	N/A	Flare Traversable RT?	N/A
N/A	Landing Length (in)	N/A	N/A	DWS Provided?	N/A
N/A	Landing Width (in)	N/A	N/A	DWS Contrast?	N/A
N/A	Landing Slope (%)	N/A	N/A	DWS Length (in)	N/A
N/A	Landing X Slope (%)	N/A	N/A	DWS Full Width?	N/A
N/A	Landing Curb? (Y/N)	N/A	N/A	DWS Offset (in)	N/A
N/A	Shared Landing?	N/A			
N/A	Gutter Ponding?	N/A	N/A	Gutter Slope (%)	N/A
N/A	Gutter Lip Ht (in)	N/A	N/A	Gutter X Slope (%)	N/A
N/A	Painted X Walk1?	No	N/A	Painted X Walk2?	No
	X Walk 1 Direction	To SW		X Walk 2 Direction	To S
	X Walk 1 Width (in)	N/A		X Walk 2 Width (in)	N/A
	X Walk 1 Slope (%)	0.5		X Walk 2 Slope (%)	0.8
	X Walk 1 X Slope (%)	0.6		X Walk 2 X Slope (%)	0.8

N/A	Ramp inside XWalk1?	N/A	N/A	Ramp inside XWalk2?	N/A
	Road Slope (%)	0.4		Clear Space?	N/A
	Road X Slope (%)	0.6	N/A	Clear Space to XWalk (in)	N/A
N/A	Any Obstructions?	N/A	N/A	Storm Grate/Utility Hazard?	N/A
	Obstruction Type			Storm Grate/Utility Type	
N/A					N/A
			Yes	Surface Condition? (G/P)	Good
			N/A	Curb Slope (%)	2.7

Remove & Replace Curb Ramp With Two New Directional Ramps or Equivalent.
