# Access Compliance Report
# Public Rights-of-Way
# (Curb Ramps)

| Intersection ID: 27815 | Main Street: BRAID_HILLS_DR | Cross Street: PROVIDENCE_COUNTRY_CLUB_DR | Location: | E |
| ADA ID: A4019E6F4963 | Ramp Type: Perp | Initial Pass/Fail: Fail | Overall Compliance: No | Severity Score: 12.5 |

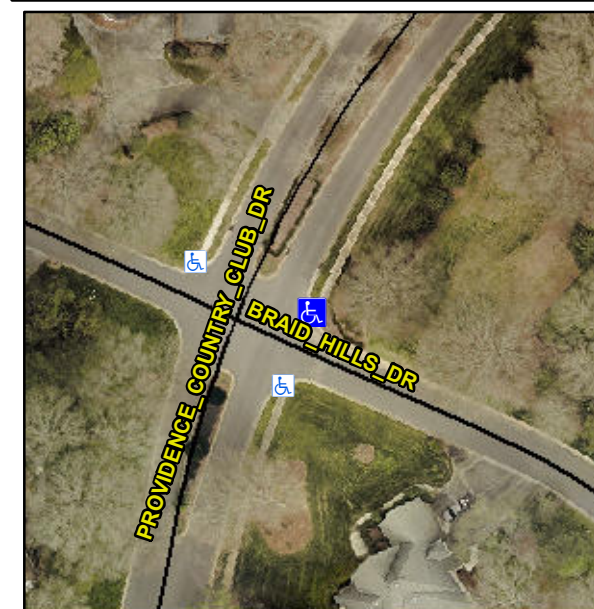
**Not Found, R304.5.3**

| Compliance | Description | Data | Compliance | Description | Data |
|---|---|---|---|---|---|
| Yes | Ramp Width (in) | 48.0 | No | Ramp XSlope (%) | 5.6 |

**Remove & Replace Entire Ramp.**
