Access Compliance Report
Public Rights-of-Way
(Curb Ramps)

Intersection ID: 15247 **Main Street:** E_INDEPENDENCE_BV **Cross Street:** EASTWAY_DR_RA **Location:** N

ADA ID: A4429173C2A5 **Ramp Type:** Perp **Initial Pass/Fail:** Fail **Overall Compliance:** No **Severity Score:** 21.25

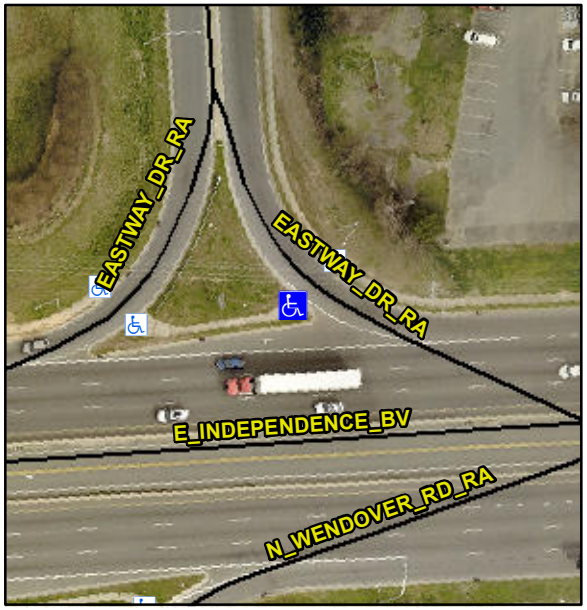
Not Found, R304.5.1, R304.2.2

Compliance	Description	Data	Compliance	Description	Data
N/A	Ramp Length (in)	54.0	No	Ramp Slope (%)	9.5
No	Ramp Width (in)	38.5	Yes	Ramp XSlope (%)	0.6
N/A	Flare Type LT	N/A	N/A	Flare Type RT	N/A
N/A	Flare Slope LT (%)	N/A	N/A	Flare Slope RT (%)	N/A
N/A	Flare Traversable LT?	N/A	N/A	Flare Traversable RT?	N/A
N/A	Landing Length (in)	N/A	N/A	DWS Provided?	N/A
N/A	Landing Width (in)	N/A	N/A	DWS Contrast?	N/A
N/A	Landing Slope (%)	N/A	N/A	DWS Length (in)	N/A
N/A	Landing X Slope (%)	N/A	N/A	DWS Full Width?	N/A
N/A	Landing Curb? (Y/N)	N/A	N/A	DWS Offset (in)	N/A
N/A	Shared Landing?	N/A			
N/A	Gutter Ponding?	N/A	N/A	Gutter Slope (%)	N/A
N/A	Gutter Lip Ht (in)	N/A	N/A	Gutter X Slope (%)	N/A
N/A	Painted X Walk1?	No	N/A	Painted X Walk2?	N/A
	X Walk 1 Direction	To NE		X Walk 2 Direction	N/A
N/A	X Walk 1 Width (in)	N/A	N/A	X Walk 2 Width (in)	N/A
	X Walk 1 Slope (%)	7.2		X Walk 2 Slope (%)	N/A
	X Walk 1 X Slope (%)	1.3		X Walk 2 X Slope (%)	N/A

Remove & Replace Entire Ramp.
