Access Compliance Report
Public Rights-of-Way
(Curb Ramps)

Intersection ID: 10032188	Main Street: MORRISON_BV	Cross Street: N/A	Location:	NW
ADA ID: A491AD569027	Ramp Type: Perp	Initial Pass/Fail: Fail	Overall Compliance: No	Severity Score: 47.5

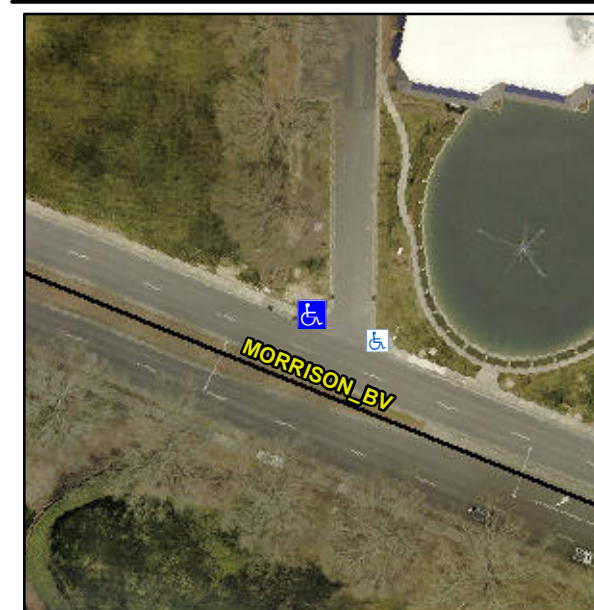
Not Found, R304.5.1, R304.2.2

Compliance	Description	Data	Compliance	Description	Data
N/A	Ramp Length (in)	48.0	No	Ramp Slope (%)	9.2
No	Ramp Width (in)	29.0	Yes	Ramp XSlope (%)	0.9
N/A	Flare Type LT	N/A	N/A	Flare Type RT	N/A
N/A	Flare Slope LT (%)	N/A	N/A	Flare Slope RT (%)	N/A
N/A	Flare Traversable LT?	N/A	N/A	Flare Traversable RT?	N/A
N/A	Landing Length (in)	N/A	N/A	DWS Provided?	N/A
N/A	Landing Width (in)	N/A	N/A	DWS Contrast?	N/A
N/A	Landing Slope (%)	N/A	N/A	DWS Length (in)	N/A
N/A	Landing X Slope (%)	N/A	N/A	DWS Full Width?	N/A
N/A	Landing Curb? (Y/N)	N/A	N/A	DWS Offset (in)	N/A
N/A	Shared Landing?	N/A			
N/A	Gutter Ponding?	N/A	N/A	Gutter Slope (%)	N/A
N/A	Gutter Lip Ht (in)	N/A	N/A	Gutter X Slope (%)	N/A
N/A	Painted X Walk1?	No	N/A	Painted X Walk2?	N/A
	X Walk 1 Direction	To SE		X Walk 2 Direction	N/A
N/A	X Walk 1 Width (in)	N/A	N/A	X Walk 2 Width (in)	N/A
	X Walk 1 Slope (%)	5.6		X Walk 2 Slope (%)	N/A
	X Walk 1 X Slope (%)	1.7		X Walk 2 X Slope (%)	N/A

Remove & Replace Entire Ramp.
