Access Compliance Report
Public Rights-of-Way
(Curb Ramps)

Intersection ID: 10029466	Main Street: KENILWORTH_AV	Cross Street: N/A	Location:	S
ADA ID: A4CE2B9253F2	Ramp Type: Directional1	Initial Pass/Fail: Fail	Overall Compliance: No	Severity Score: 12.5

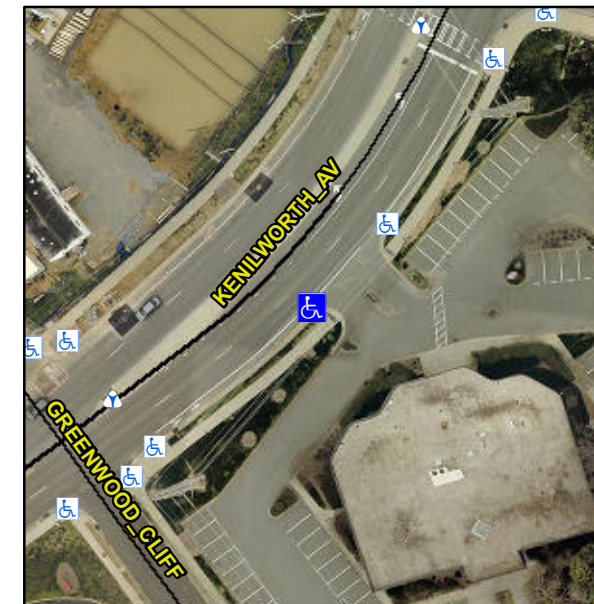
R304.2.2

Compliance	Description	Data	Compliance	Description	Data
N/A	Ramp Length (in)	84.0	N/A	Grade Break?	N/A
Yes	Ramp Width (in)	70.0	N/A	Grade Break Slope (%)	0.0
No	Ramp Slope (%)	8.8	N/A	Grade Break XSlope (%)	0.0
Yes	Ramp XSlope (%)	0.6			
N/A	Flare Type LT	N/A	N/A	Flare Type RT	N/A
N/A	Flare Slope LT (%)	N/A	N/A	Flare Slope RT (%)	0.0
N/A	Flare Traversable LT?	N/A	N/A	Flare Traversable RT?	N/A
N/A	Landing Length (in)	0.0	N/A	DWS Provided?	N/A
N/A	Landing Width (in)	0.0	N/A	DWS Contrast?	N/A
N/A	Landing Slope (%)	0.0	N/A	DWS Length (in)	N/A
N/A	Landing X Slope (%)	0.0	N/A	DWS Full Width?	N/A
N/A	Landing Curb? (Y/N)	N/A	N/A	DWS Offset LT (in)	N/A
N/A	Shared Landing?	N/A	N/A	DWS Offset RT (in)	N/A
N/A	Gutter Ponding?	0.0	N/A	Gutter Slope (%)	N/A
N/A	Gutter Lip Ht (in)	0.0	N/A	Gutter X Slope (%)	N/A
N/A	Painted X Walk1?	No		Road Slope (%)	0.2
	X Walk 1 Direction	To NE		Road X Slope (%)	4.1
	X Walk 1 Width (in)	N/A		Clear Space?	N/A

Remove & Replace Entire Ramp.
