Access Compliance Report
Public Rights-of-Way
(Curb Ramps)

Intersection ID: 31435	Main Street: CHEVIOTT_HILL_LN	Cross Street: O_CASEY_LN	Location:	SE
ADA ID: A4F54AEBE11E	Ramp Type: PerpDiag	Initial Pass/Fail: Fail	Overall Compliance: No	Severity Score: 8.75

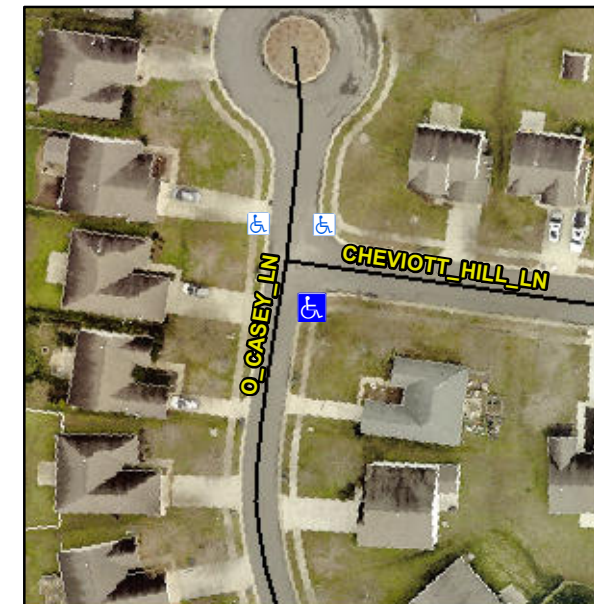
Not Found, R304.5.1

Compliance	Description	Data	Compliance	Description	Data
N/A	Ramp Length (in)	47.0	Yes	Ramp Slope (%)	8.1
No	Ramp Width (in)	39.0	Yes	Ramp XSlope (%)	0.5
N/A	Flare Type LT	N/A	N/A	Flare Type RT	N/A
N/A	Flare Slope LT (%)	N/A	N/A	Flare Slope RT (%)	N/A
N/A	Flare Traversable LT?	N/A	N/A	Flare Traversable RT?	N/A
N/A	Landing Length (in)	N/A	N/A	DWS Provided?	N/A
N/A	Landing Width (in)	N/A	N/A	DWS Contrast?	N/A
N/A	Landing Slope (%)	N/A	N/A	DWS Length (in)	N/A
N/A	Landing X Slope (%)	N/A	N/A	DWS Full Width?	N/A
N/A	Landing Curb? (Y/N)	N/A	N/A	DWS Offset (in)	N/A
N/A	Shared Landing?	N/A			
N/A	Gutter Ponding?	N/A	N/A	Gutter Slope (%)	N/A
N/A	Gutter Lip Ht (in)	1.0	N/A	Gutter X Slope (%)	N/A
N/A	Painted X Walk1?	No	N/A	Painted X Walk2?	No
	X Walk 1 Direction	To N		X Walk 2 Direction	To W
N/A	X Walk 1 Width (in)	N/A	N/A	X Walk 2 Width (in)	N/A
	X Walk 1 Slope (%)	1.2		X Walk 2 Slope (%)	2.2
	X Walk 1 X Slope (%)	1.1		X Walk 2 X Slope (%)	3.0

Remove & Replace Curb Ramp With Two New Directional Ramps or Equivalent.
