Access Compliance Report
Public Rights-of-Way
(Curb Ramps)

Intersection ID: 21456	Main Street: REGENT_RIDGE_LN	Cross Street: WITHERS_MILL_DR	Location: E
ADA ID: A559F8B81A3B	Ramp Type: Directional1	Initial Pass/Fail: Fail	Overall Compliance: No	Severity Score: 12.5

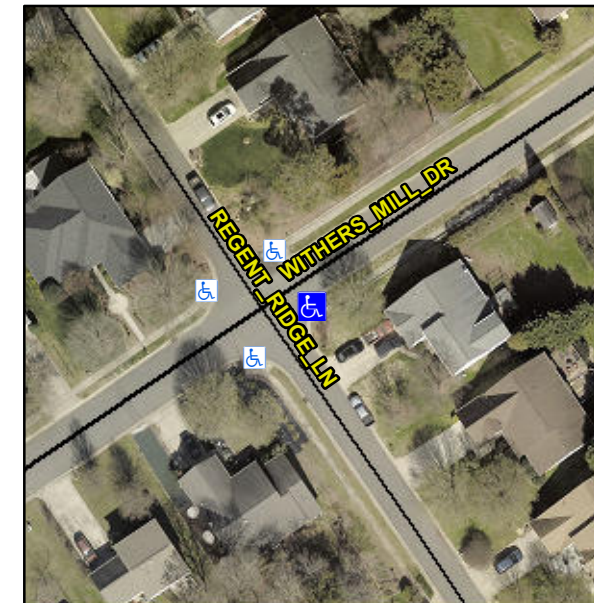
R304.5.3

Compliance	Description	Data	Compliance	Description	Data
N/A	Ramp Length (in)	48.0	N/A	Grade Break?	N/A
Yes	Ramp Width (in)	48.0	N/A	Grade Break Slope (%)	0.0
Yes	Ramp Slope (%)	5.0	N/A	Grade Break XSlope (%)	0.0
No	Ramp XSlope (%)	6.2			
N/A	Flare Type LT	N/A	N/A	Flare Type RT	N/A
N/A	Flare Slope LT (%)	N/A	N/A	Flare Slope RT (%)	0.0
N/A	Flare Traversable LT?	N/A	N/A	Flare Traversable RT?	N/A
N/A	Landing Length (in)	0.0	N/A	DWS Provided?	N/A
N/A	Landing Width (in)	0.0	N/A	DWS Contrast?	N/A
N/A	Landing Slope (%)	0.0	N/A	DWS Length (in)	N/A
N/A	Landing X Slope (%)	0.0	N/A	DWS Full Width?	N/A
N/A	Landing Curb? (Y/N)	N/A	N/A	DWS Offset LT (in)	N/A
N/A	Shared Landing?	N/A	N/A	DWS Offset RT (in)	N/A
N/A	Gutter Ponding?	0.0	N/A	Gutter Slope (%)	N/A
N/A	Gutter Lip Ht (in)	0.0	N/A	Gutter X Slope (%)	N/A
N/A	Painted X Walk1?	No		Road Slope (%)	3.8
	X Walk 1 Direction	To SW		Road X Slope (%)	3.7
	X Walk 1 Width (in)	N/A		Clear Space?	N/A

Remove & Replace Entire Ramp.
