# Access Compliance Report
Public Rights-of-Way
(Curb Ramps)

Intersection ID: 28977	Main Street: BANNINGTON_RD	Cross Street: BEROLINA_LN	Location:	NE
ADA ID: A56F6896B79A	Ramp Type: PerpDiag	Initial Pass/Fail: Fail	Overall Compliance: No	Severity Score: 10

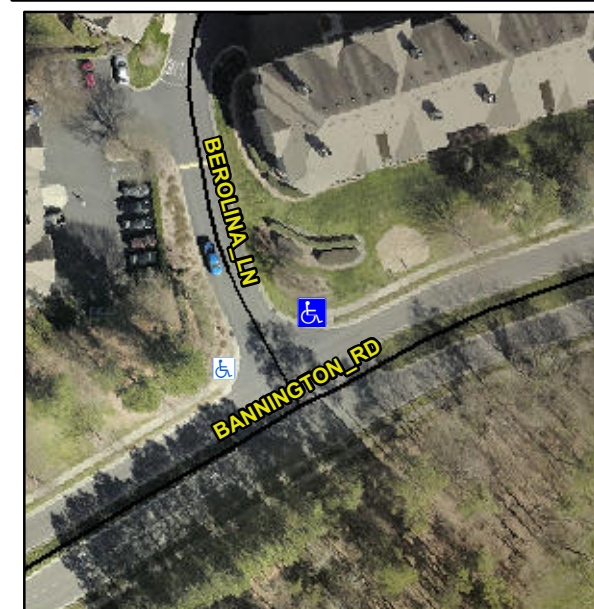
Not Found, R304.5.1, R304.5.3

Compliance	Description	Data	Compliance	Description	Data
N/A	Ramp Length (in)	95.0	Yes	Ramp Slope (%)	6.0
No	Ramp Width (in)	38.5	No	Ramp XSlope (%)	3.3
N/A	Flare Type LT	N/A	N/A	Flare Type RT	N/A
N/A	Flare Slope LT (%)	N/A	N/A	Flare Slope RT (%)	N/A
N/A	Flare Traversable LT?	N/A	N/A	Flare Traversable RT?	N/A
N/A	Landing Length (in)	N/A	N/A	DWS Provided?	N/A
N/A	Landing Width (in)	N/A	N/A	DWS Contrast?	N/A
N/A	Landing Slope (%)	N/A	N/A	DWS Length (in)	N/A
N/A	Landing X Slope (%)	N/A	N/A	DWS Full Width?	N/A
N/A	Landing Curb? (Y/N)	N/A	N/A	DWS Offset (in)	N/A
N/A	Shared Landing?	N/A			
N/A	Gutter Ponding?	N/A	N/A	Gutter Slope (%)	N/A
N/A	Gutter Lip Ht (in)	N/A	N/A	Gutter X Slope (%)	N/A
N/A	Painted X Walk1?	No	N/A	Painted X Walk2?	No
	X Walk 1 Direction	To W		X Walk 2 Direction	To S
N/A	X Walk 1 Width (in)	N/A	N/A	X Walk 2 Width (in)	N/A
	X Walk 1 Slope (%)	3.1		X Walk 2 Slope (%)	0.8
	X Walk 1 X Slope (%)	0.6		X Walk 2 X Slope (%)	2.9

N/A	Ramp inside XWalk1?	N/A	N/A	Ramp inside XWalk2?	N/A
	Road Slope (%)	3.3	N/A	Clear Space?	N/A
	Road X Slope (%)	1.2	N/A	Clear Space to XWalk (in)	N/A
N/A	Any Obstructions?	N/A	N/A	Storm Grate/Utility Hazard?	N/A
	Obstruction Type			Storm Grate/Utility Type	
N/A					N/A
			Yes	Surface Condition? (G/P)	Good

Remove & Replace Curb Ramp With Two New Directional Ramps or Equivalent.
