# Access Compliance Report
# Public Rights-of-Way
# (Curb Ramps)

**Intersection ID:** 23730 | **Main Street:** PROVIDENCE_RD | **Cross Street:** CEDAR_CROFT_DR | **Location:** NW

**ADA ID:** A5B0AE57FE54 | **Ramp Type:** Perp | **Initial Pass/Fail:** Fail | **Overall Compliance:** No | **Severity Score:** 42.5

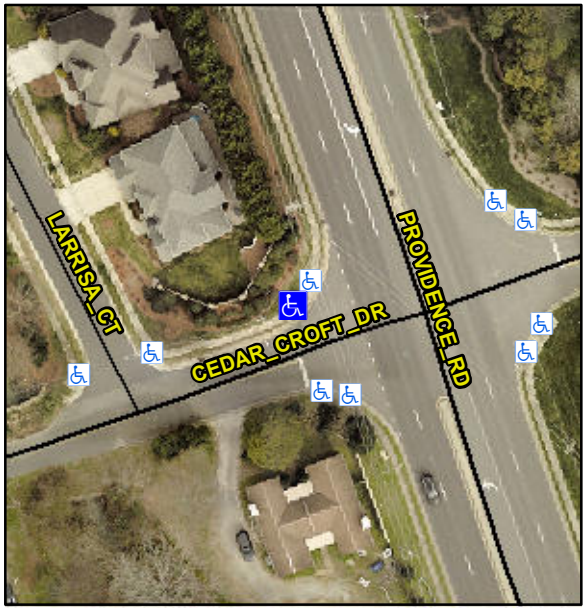
**R304.5.1, R304.2.2, R304.5.3**

| Compliance | Description | Data | Compliance | Description | Data |
|---|---|---|---|---|---|
| N/A | Ramp Length (in) | 70.5 | No | Ramp Slope (%) | 8.7 |
| No | Ramp Width (in) | 33.0 | No | Ramp XSlope (%) | 5.5 |

**Remove & Replace Entire Ramp.**
