Access Compliance Report
Public Rights-of-Way
(Curb Ramps)

Intersection ID: 14145	**Main Street:** MT_VERNON_AV	**Cross Street:** DILWORTH_CRESCENT_RW	**Location:** NE
ADA ID: A5DCEF85C4F5	**Ramp Type:** PerpDiag	**Initial Pass/Fail:** Fail **Overall Compliance:** No	**Severity Score:** 13.75

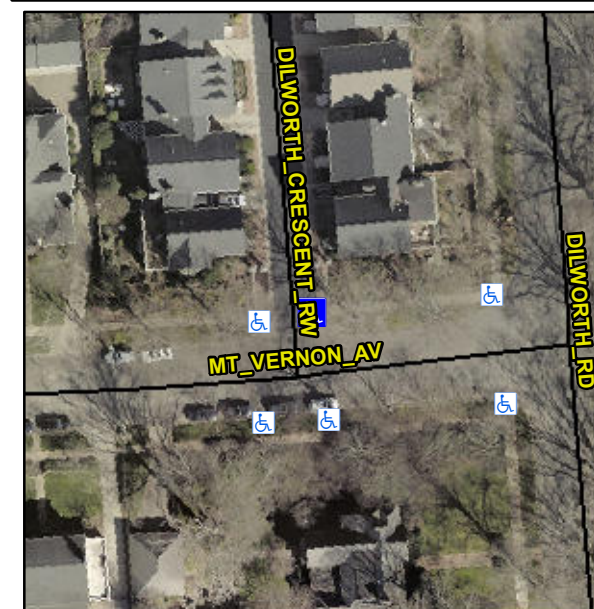
R304.2.2, R304.5.3

Compliance	Description	Data	Compliance	Description	Data
N/A	Ramp Length (in)	48.0	No	Ramp Slope (%)	9.7
Yes	Ramp Width (in)	48.0	No	Ramp XSlope (%)	2.9
N/A	Flare Type LT	N/A	N/A	Flare Type RT	N/A
N/A	Flare Slope LT (%)	N/A	N/A	Flare Slope RT (%)	N/A
N/A	Flare Traversable LT?	N/A	N/A	Flare Traversable RT?	N/A
N/A	Landing Length (in)	N/A	N/A	DWS Provided?	N/A
N/A	Landing Width (in)	N/A	N/A	DWS Contrast?	N/A
N/A	Landing Slope (%)	N/A	N/A	DWS Length (in)	N/A
N/A	Landing X Slope (%)	N/A	N/A	DWS Full Width?	N/A
N/A	Landing Curb? (Y/N)	N/A	N/A	DWS Offset (in)	N/A
N/A	Shared Landing?	N/A			
N/A	Gutter Ponding?	N/A	N/A	Gutter Slope (%)	N/A
N/A	Gutter Lip Ht (in)	2.0	N/A	Gutter X Slope (%)	N/A
N/A	Painted X Walk1?	No	N/A	Painted X Walk2?	No
	X Walk 1 Direction	To W		X Walk 2 Direction	To S
N/A	X Walk 1 Width (in)	N/A	N/A	X Walk 2 Width (in)	N/A
	X Walk 1 Slope (%)	0.7		X Walk 2 Slope (%)	0.5
	X Walk 1 X Slope (%)	2.9		X Walk 2 X Slope (%)	1.1

Remove & Replace Curb Ramp With Two New Directional Ramps or Equivalent.
