Access Compliance Report
Public Rights-of-Way
(Curb Ramps)

Intersection ID: 43641	**Main Street:** HUNTINGTON_MEADOW_LN	**Cross Street:** KENDRICK_CROSS_RD	**Location:**	**NW**
ADA ID: A64A44BD41D0	**Ramp Type:** PerpDiag	**Initial Pass/Fail:** Fail	**Overall Compliance:** No	**Severity Score:** 8.75

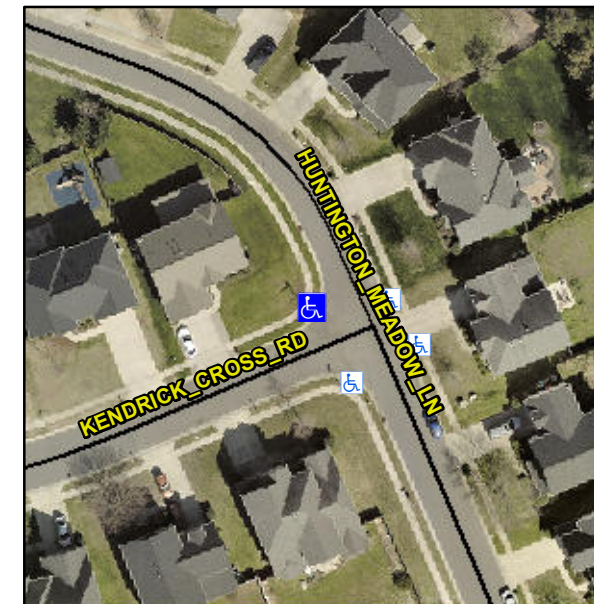
Not Found, R304.5.1

Compliance	Description	Data	Compliance	Description	Data
N/A	Ramp Length (in)	96.0	Yes	Ramp Slope (%)	6.4
No	Ramp Width (in)	38.0	Yes	Ramp XSlope (%)	1.6
N/A	Flare Type LT	N/A	N/A	Flare Type RT	N/A
N/A	Flare Slope LT (%)	N/A	N/A	Flare Slope RT (%)	N/A
N/A	Flare Traversable LT?	N/A	N/A	Flare Traversable RT?	N/A
N/A	Landing Length (in)	N/A	N/A	DWS Provided?	N/A
N/A	Landing Width (in)	N/A	N/A	DWS Contrast?	N/A
N/A	Landing Slope (%)	N/A	N/A	DWS Length (in)	N/A
N/A	Landing X Slope (%)	N/A	N/A	DWS Full Width?	N/A
N/A	Landing Curb? (Y/N)	N/A	N/A	DWS Offset (in)	N/A
N/A	Shared Landing?	N/A			
N/A	Gutter Ponding?	N/A	N/A	Gutter Slope (%)	N/A
N/A	Gutter Lip Ht (in)	N/A	N/A	Gutter X Slope (%)	N/A
N/A	Painted X Walk1?	No	N/A	Painted X Walk2?	No
	X Walk 1 Direction	To S		X Walk 2 Direction	To E
N/A	X Walk 1 Width (in)	N/A	N/A	X Walk 2 Width (in)	N/A
	X Walk 1 Slope (%)	2.0		X Walk 2 Slope (%)	3.8
	X Walk 1 X Slope (%)	0.7		X Walk 2 X Slope (%)	2.0

N/A	Ramp inside XWalk1?	N/A	N/A	Ramp inside XWalk2?	N/A
	Road Slope (%)	1.9	N/A	Clear Space?	N/A
	Road X Slope (%)	1.5	N/A	Clear Space to XWalk (in)	N/A
N/A	Any Obstructions?	N/A	N/A	Storm Grate/Utility Hazard?	N/A
	Obstruction Type			Storm Grate/Utility Type	
N/A					N/A
			Yes	Surface Condition? (G/P)	Good

Remove & Replace Curb Ramp With Two New Directional Ramps or Equivalent.
