Access Compliance Report
Public Rights-of-Way
(Curb Ramps)

Intersection ID: 12548	Main Street: E_MARTIN_LUTHER_KING_JR_BV	Cross Street: S_TRYON_ST	Location: E
ADA ID: A665D5F7D94D	Ramp Type: PerpDiag	Initial Pass/Fail: Fail	Overall Compliance: No	Severity Score: 12.5

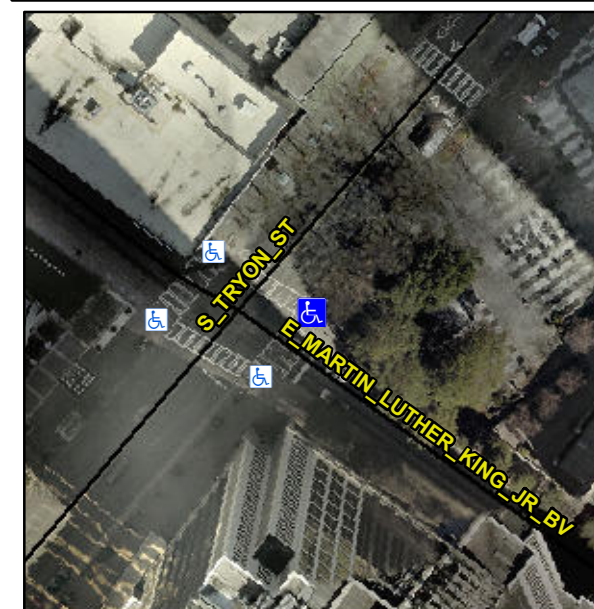
Compliance	Description	Data	Compliance	Description	Data
N/A	Ramp Length (in)	64.0	No	Ramp Slope (%)	8.4
Yes	Ramp Width (in)	67.0	Yes	Ramp XSlope (%)	1.8
N/A	Flare Type LT	N/A	N/A	Flare Type RT	N/A
N/A	Flare Slope LT (%)	N/A	N/A	Flare Slope RT (%)	N/A
N/A	Flare Traversable LT?	N/A	N/A	Flare Traversable RT?	N/A
N/A	Landing Length (in)	N/A	N/A	DWS Provided?	N/A
N/A	Landing Width (in)	N/A	N/A	DWS Contrast?	N/A
N/A	Landing Slope (%)	N/A	N/A	DWS Length (in)	N/A
N/A	Landing X Slope (%)	N/A	N/A	DWS Full Width?	N/A
N/A	Landing Curb? (Y/N)	N/A	N/A	DWS Offset (in)	N/A
N/A	Shared Landing?	N/A			
N/A	Gutter Ponding?	N/A	N/A	Gutter Slope (%)	N/A
N/A	Gutter Lip Ht (in)	N/A	N/A	Gutter X Slope (%)	N/A
N/A	Painted X Walk1?	Yes	N/A	Painted X Walk2?	Yes
	X Walk 1 Direction	To NW		X Walk 2 Direction	To SW
N/A	X Walk 1 Width (in)	108.0	N/A	X Walk 2 Width (in)	188.0
	X Walk 1 Slope (%)	1.2		X Walk 2 Slope (%)	0.9
	X Walk 1 X Slope (%)	0.7		X Walk 2 X Slope (%)	0.8

N/A	Ramp inside XWalk1?	Yes	N/A	Ramp inside XWalk2?	Yes
	Road Slope (%)	1.3	N/A	Clear Space?	N/A
	Road X Slope (%)	1.5	N/A	Clear Space to XWalk (in)	N/A
N/A	Any Obstructions?	N/A	N/A	Storm Grate/Utility Hazard?	N/A
	Obstruction Type			Storm Grate/Utility Type	
N/A					N/A
			Yes	Surface Condition? (G/P)	Good

Remove & Replace Curb Ramp With Two New Directional Ramps or Equivalent.
