# Access Compliance Report

## Public Rights-of-Way
## (Curb Ramps)

| Intersection ID: 30490 | Main Street: BRAMWYCK_DR | Cross Street: QUAIL_PARK_DR | Location: SW |
| ADA ID: A6ABAAF34A7A | Ramp Type: PerpDiag | Initial Pass/Fail: Fail | Overall Compliance: No | Severity Score: 10 |

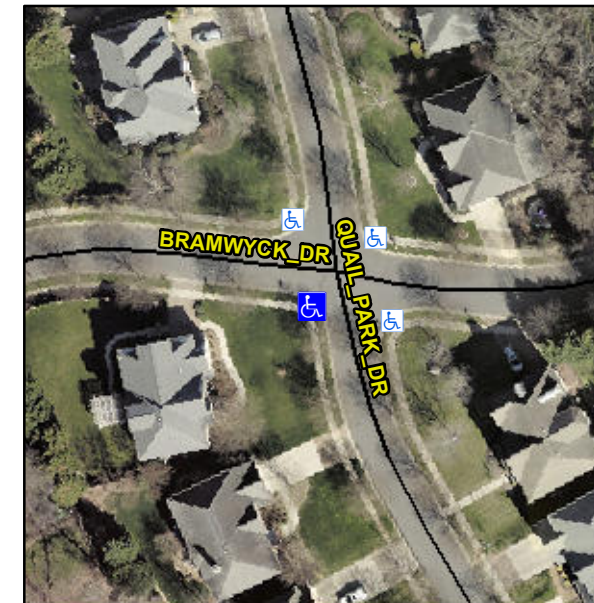
Not Found, R304.5.1, R304.5.3

| Compliance | Description | Data | Compliance | Description | Data |
|---|---|---|---|---|---|
| No | Ramp Width (in) | 40.0 | No | Ramp XSlope (%) | 2.4 |

Remove & Replace Curb Ramp With Two New Directional Ramps or Equivalent.
