# Access Compliance Report
# Public Rights-of-Way
# (Curb Ramps)

| **Intersection ID:** 3064 | **Main Street:** BLACK_MAPLE_AV | **Cross Street:** HEDGE_MAPLE_RD | **Location:** N |
| **ADA ID:** A6B188DAC65F | **Ramp Type:** Perp | **Initial Pass/Fail:** Fail | **Overall Compliance:** No **Severity Score:** 8.75 |

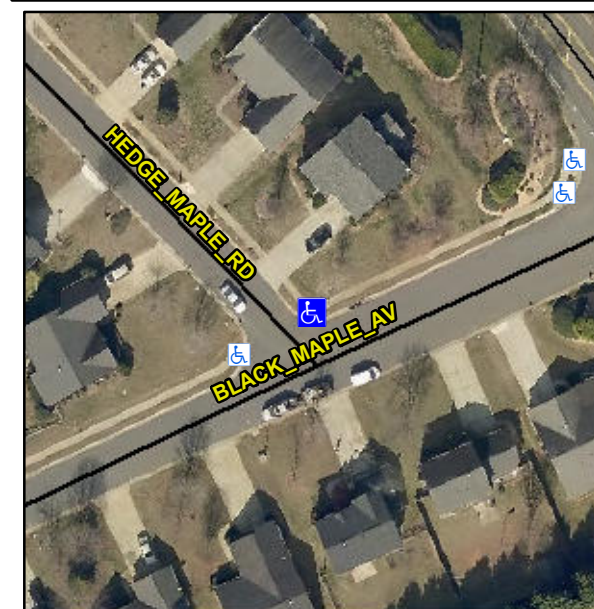
**R304.5.1**

| Compliance | Description | Data | Compliance | Description | Data |
|---|---|---|---|---|---|
| No | Ramp Width (in) | 45.0 | Yes | Ramp XSlope (%) | 1.2 |

**Remove & Replace Entire Ramp.**

**Total Cost:**  **$ 1850.00**
