Access Compliance Report

## Public Rights-of-Way
(Curb Ramps)

Intersection ID: 28709	**Main Street:** FERRUM_LN	**Cross Street:** GREYBRIAR_FOREST_LN	**Location:** E
ADA ID: A6D538BFB892	**Ramp Type:** PerpDiag	**Initial Pass/Fail:** Fail	**Overall Compliance:** No	**Severity Score:** 13.75

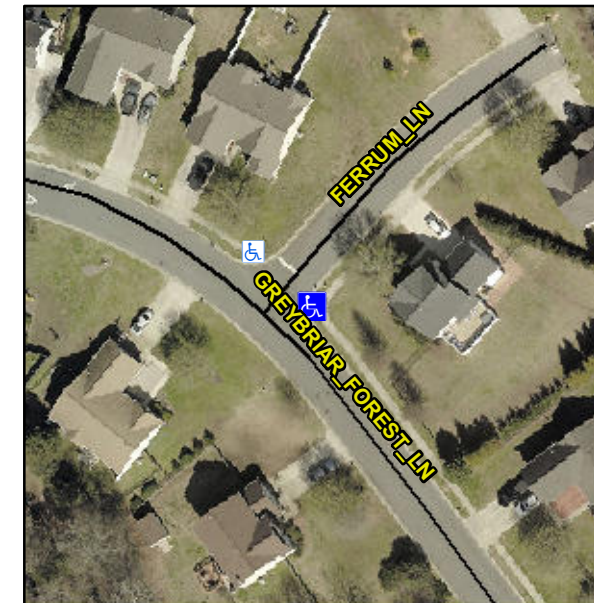
Not Found, R304.2.2, R304.5.3

Compliance	Description	Data	Compliance	Description	Data
N/A	Ramp Length (in)	93.0	No	Ramp Slope (%)	9.8
Yes	Ramp Width (in)	88.5	No	Ramp XSlope (%)	4.7
N/A	Flare Type LT	N/A	N/A	Flare Type RT	N/A
N/A	Flare Slope LT (%)	N/A	N/A	Flare Slope RT (%)	N/A
N/A	Flare Traversable LT?	N/A	N/A	Flare Traversable RT?	N/A
N/A	Landing Length (in)	N/A	N/A	DWS Provided?	N/A
N/A	Landing Width (in)	N/A	N/A	DWS Contrast?	N/A
N/A	Landing Slope (%)	N/A	N/A	DWS Length (in)	N/A
N/A	Landing X Slope (%)	N/A	N/A	DWS Full Width?	N/A
N/A	Landing Curb? (Y/N)	N/A	N/A	DWS Offset (in)	N/A
N/A	Shared Landing?	N/A			
N/A	Gutter Ponding?	N/A	N/A	Gutter Slope (%)	N/A
N/A	Gutter Lip Ht (in)	N/A	N/A	Gutter X Slope (%)	N/A
N/A	Painted X Walk1?	No	N/A	Painted X Walk2?	No
	X Walk 1 Direction	To NW		X Walk 2 Direction	To SW
N/A	X Walk 1 Width (in)	N/A	N/A	X Walk 2 Width (in)	N/A
	X Walk 1 Slope (%)	6.9		X Walk 2 Slope (%)	3.3
	X Walk 1 X Slope (%)	1.8		X Walk 2 X Slope (%)	5.7

Remove & Replace Curb Ramp With Two New Directional Ramps or Equivalent.
