Access Compliance Report
Public Rights-of-Way
(Curb Ramps)

Intersection ID: N/A	**Main Street:** PALUSTRIS_CT	**Cross Street:** N/A	**Location:** E
ADA ID: A73041C6263D	**Ramp Type:** Perp	**Initial Pass/Fail:** Fail **Overall Compliance:** No	**Severity Score:** 21.25

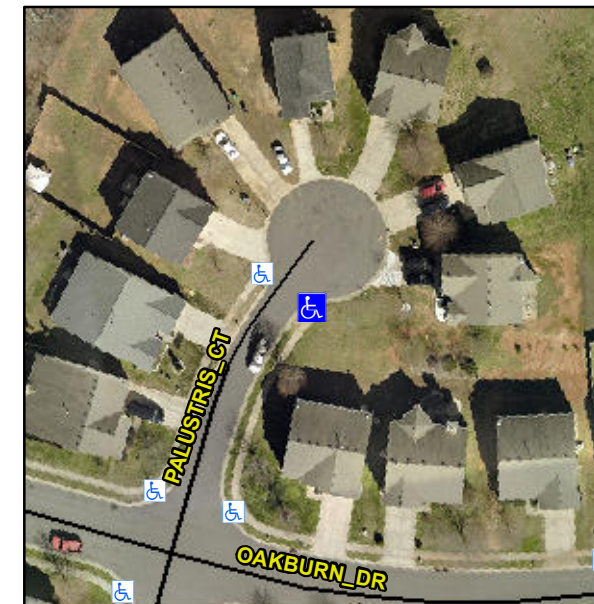
Not Found, R304.5.1, R304.2.2

Compliance	Description	Data	Compliance	Description	Data
N/A	Ramp Length (in)	48.0	No	Ramp Slope (%)	10.2
No	Ramp Width (in)	45.0	Yes	Ramp XSlope (%)	0.9
N/A	Flare Type LT	N/A	N/A	Flare Type RT	N/A
N/A	Flare Slope LT (%)	N/A	N/A	Flare Slope RT (%)	N/A
N/A	Flare Traversable LT?	N/A	N/A	Flare Traversable RT?	N/A
N/A	Landing Length (in)	N/A	N/A	DWS Provided?	N/A
N/A	Landing Width (in)	N/A	N/A	DWS Contrast?	N/A
N/A	Landing Slope (%)	N/A	N/A	DWS Length (in)	N/A
N/A	Landing X Slope (%)	N/A	N/A	DWS Full Width?	N/A
N/A	Landing Curb? (Y/N)	N/A	N/A	DWS Offset (in)	N/A
N/A	Shared Landing?	N/A			
N/A	Gutter Ponding?	N/A	N/A	Gutter Slope (%)	N/A
N/A	Gutter Lip Ht (in)	N/A	N/A	Gutter X Slope (%)	N/A
N/A	Painted X Walk1?	No	N/A	Painted X Walk2?	N/A
	X Walk 1 Direction	To W		X Walk 2 Direction	N/A
N/A	X Walk 1 Width (in)	N/A	N/A	X Walk 2 Width (in)	N/A
	X Walk 1 Slope (%)	1.6		X Walk 2 Slope (%)	N/A
	X Walk 1 X Slope (%)	4.0		X Walk 2 X Slope (%)	N/A

Remove & Replace Entire Ramp.
