# Access Compliance Report
# Public Rights-of-Way
# (Curb Ramps)

| Intersection ID: 53095 | Main Street: ALEXANDER_DOWD_DR | Cross Street: DEERFIELD_MANOR_DR | Location: W |
| ADA ID: A76372CBE7B0 | Ramp Type: Perp | Initial Pass/Fail: Fail | Overall Compliance: No | Severity Score: 12.5 |

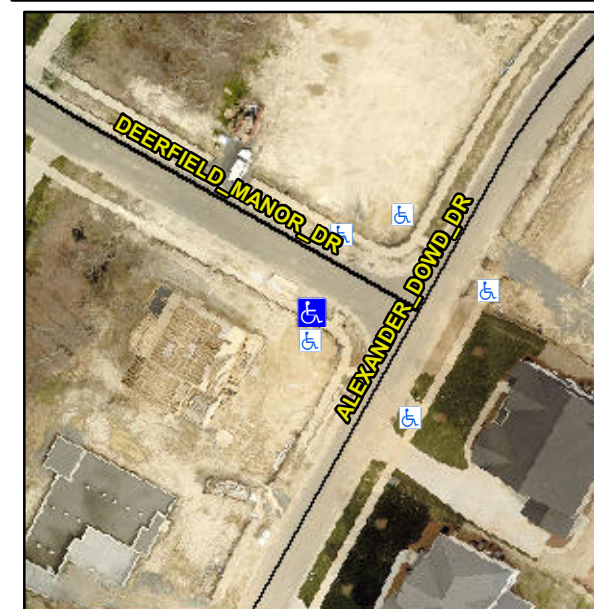
**Not Found, R304.5.3**

| Compliance | Description | Data | Compliance | Description | Data |
|---|---|---|---|---|---|
| Yes | Ramp Width (in) | 48.0 | No | Ramp XSlope (%) | 5.2 |

**Remove & Replace Entire Ramp.**
