Access Compliance Report
Public Rights-of-Way
(Curb Ramps)

Intersection ID: 49394	Main Street: BENGALI_CR	Cross Street: ROMANA_RED_LN	Location: SE
ADA ID: A8728C650B9B	Ramp Type: PerpDiag	Initial Pass/Fail: Pass	Overall Compliance: No — Severity Score: 0

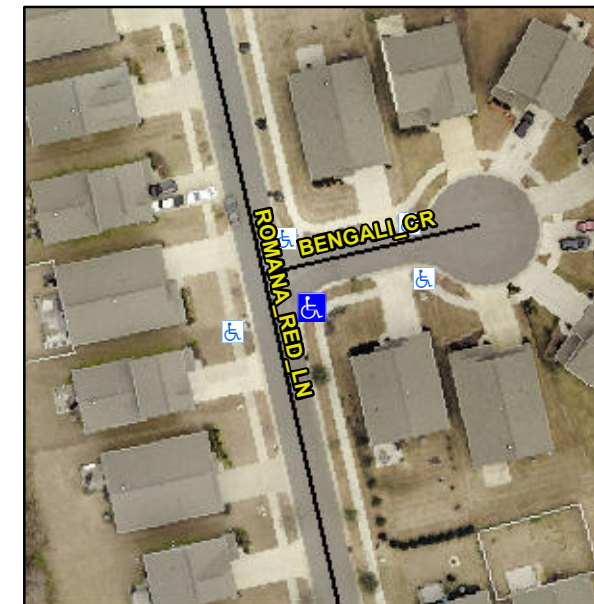
Not Found, R304.2.2-Perp, R304.3.2-Para, R305.2

Compliance	Description	Data	Compliance	Description	Data
N/A	Ramp Length (in)	72.0	Yes	Ramp Slope (%)	8.1
Yes	Ramp Width (in)	48.0	Yes	Ramp XSlope (%)	1.3
N/A	Flare Type LT	Sloped	N/A	Flare Type RT	N/A
N/A	Flare Slope LT (%)	5.5	N/A	Flare Slope RT (%)	11.0
N/A	Flare Traversable LT?	No	N/A	Flare Traversable RT?	No
Yes	Landing Length (in)	60.0	Yes	DWS Provided?	Yes
Yes	Landing Width (in)	52.0	Yes	DWS Contrast?	Yes
No	Landing Slope (%)	3.2	Yes	DWS Length (in)	24.0
Yes	Landing X Slope (%)	0.7	Yes	DWS Full Width?	Yes
N/A	Landing Curb? (Y/N)	No	No	DWS Offset (in)	7.0
N/A	Shared Landing?	No			
Yes	Gutter Ponding?	No	Yes	Gutter Slope (%)	2.3
Yes	Gutter Lip Ht (in)	0.0	Yes	Gutter X Slope (%)	0.7
N/A	Painted X Walk1?	No	N/A	Painted X Walk2?	No
	X Walk 1 Direction	To N		X Walk 2 Direction	To W
N/A	X Walk 1 Width (in)	N/A	N/A	X Walk 2 Width (in)	N/A
	X Walk 1 Slope (%)	1.4		X Walk 2 Slope (%)	3.5
	X Walk 1 X Slope (%)	0.4		X Walk 2 X Slope (%)	1.2

N/A	Ramp inside XWalk1?	N/A	N/A	Ramp inside XWalk2?	N/A
	Road Slope (%)	0.1	N/A	Clear Space?	Yes
	Road X Slope (%)	1.1	N/A	Clear Space to XWalk (in)	N/A
Yes	Any Obstructions?	No	Yes	Storm Grate/Utility Hazard?	No
	Obstruction Type			Storm Grate/Utility Type	
N/A					N/A
			Yes	Surface Condition? (G/P)	Good

Remove & Replace Curb Ramp With Two New Directional Ramps or Equivalent.
