Access Compliance Report
Public Rights-of-Way
(Curb Ramps)

Intersection ID: 18369	**Main Street:** RUNNYMEDE_LN	**Cross Street:** WINDSOR_DR	**Location:**	**SE**
ADA ID: A8848F739919	**Ramp Type:** PerpDiag	**Initial Pass/Fail:** Fail	**Overall Compliance:** No	**Severity Score:** 12.5

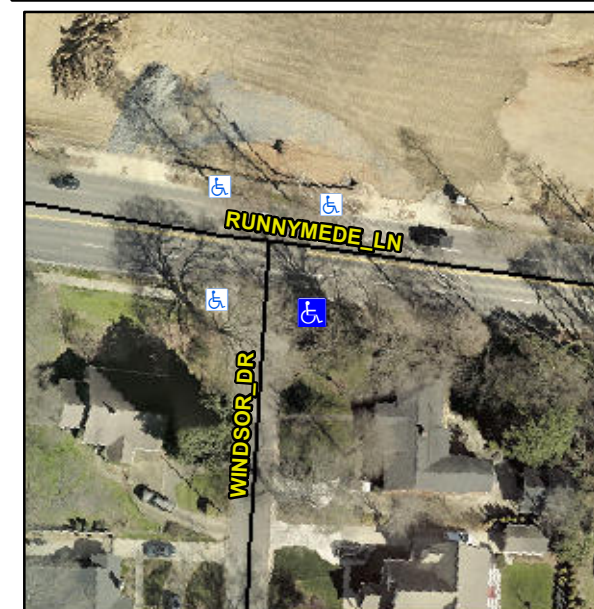
Not Found, R304.5.3

Compliance	Description	Data	Compliance	Description	Data
N/A	Ramp Length (in)	62.0	Yes	Ramp Slope (%)	7.5
Yes	Ramp Width (in)	58.0	No	Ramp XSlope (%)	5.5
N/A	Flare Type LT	N/A	N/A	Flare Type RT	N/A
N/A	Flare Slope LT (%)	N/A	N/A	Flare Slope RT (%)	N/A
N/A	Flare Traversable LT?	N/A	N/A	Flare Traversable RT?	N/A
N/A	Landing Length (in)	N/A	N/A	DWS Provided?	N/A
N/A	Landing Width (in)	N/A	N/A	DWS Contrast?	N/A
N/A	Landing Slope (%)	N/A	N/A	DWS Length (in)	N/A
N/A	Landing X Slope (%)	N/A	N/A	DWS Full Width?	N/A
N/A	Landing Curb? (Y/N)	N/A	N/A	DWS Offset (in)	N/A
N/A	Shared Landing?	N/A			
N/A	Gutter Ponding?	N/A	N/A	Gutter Slope (%)	N/A
N/A	Gutter Lip Ht (in)	N/A	N/A	Gutter X Slope (%)	N/A
N/A	Painted X Walk1?	No	N/A	Painted X Walk2?	No
	X Walk 1 Direction	To N		X Walk 2 Direction	To W
N/A	X Walk 1 Width (in)	N/A	N/A	X Walk 2 Width (in)	N/A
	X Walk 1 Slope (%)	2.8		X Walk 2 Slope (%)	10.5
	X Walk 1 X Slope (%)	7.0		X Walk 2 X Slope (%)	1.2

Remove & Replace Curb Ramp With Two New Directional Ramps or Equivalent.
