Access Compliance Report
Public Rights-of-Way
(Curb Ramps)

Intersection ID: 9302	Main Street: HIGHLAKE_DR	Cross Street: LAKECREST_DR	Location:	SW
ADA ID: A8849210C651	Ramp Type: Perp	Initial Pass/Fail: Fail	Overall Compliance: No	Severity Score: 10

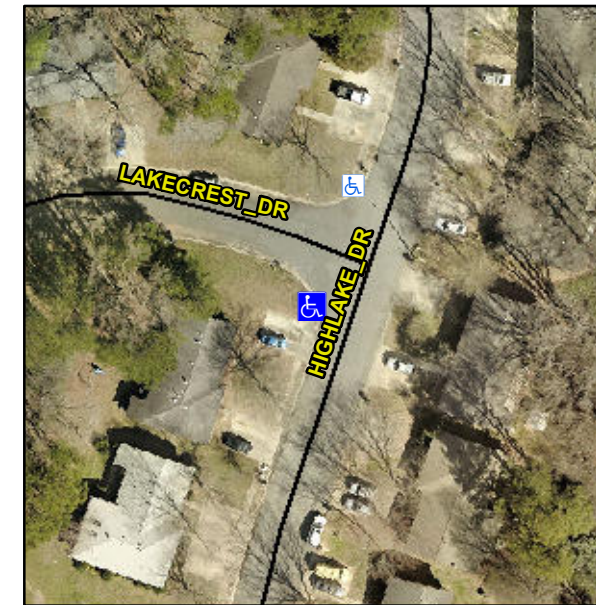
Not Found, R304.5.1, R304.5.3

Compliance	Description	Data	Compliance	Description	Data
N/A	Ramp Length (in)	50.0	Yes	Ramp Slope (%)	5.2
No	Ramp Width (in)	47.5	No	Ramp XSlope (%)	4.3
N/A	Flare Type LT	N/A	N/A	Flare Type RT	N/A
N/A	Flare Slope LT (%)	N/A	N/A	Flare Slope RT (%)	N/A
N/A	Flare Traversable LT?	N/A	N/A	Flare Traversable RT?	N/A
N/A	Landing Length (in)	N/A	N/A	DWS Provided?	N/A
N/A	Landing Width (in)	N/A	N/A	DWS Contrast?	N/A
N/A	Landing Slope (%)	N/A	N/A	DWS Length (in)	N/A
N/A	Landing X Slope (%)	N/A	N/A	DWS Full Width?	N/A
N/A	Landing Curb? (Y/N)	N/A	N/A	DWS Offset (in)	N/A
N/A	Shared Landing?	N/A			
N/A	Gutter Ponding?	N/A	N/A	Gutter Slope (%)	N/A
N/A	Gutter Lip Ht (in)	0.5	N/A	Gutter X Slope (%)	N/A
N/A	Painted X Walk1?	No	N/A	Painted X Walk2?	N/A
	X Walk 1 Direction	To NE		X Walk 2 Direction	N/A
N/A	X Walk 1 Width (in)	N/A	N/A	X Walk 2 Width (in)	N/A
	X Walk 1 Slope (%)	4.3		X Walk 2 Slope (%)	N/A
	X Walk 1 X Slope (%)	2.5		X Walk 2 X Slope (%)	N/A

Remove & Replace Entire Ramp.
