Access Compliance Report
Public Rights-of-Way
(Curb Ramps)

Intersection ID: 46786	Main Street: MILLSTREAM_RIDGE_DR	Cross Street: AUTUMN_HARVEST_LN	Location:	NE
ADA ID: A996D28778A5	Ramp Type: PerpDiag	Initial Pass/Fail: Fail	Overall Compliance: No	Severity Score: 37.5

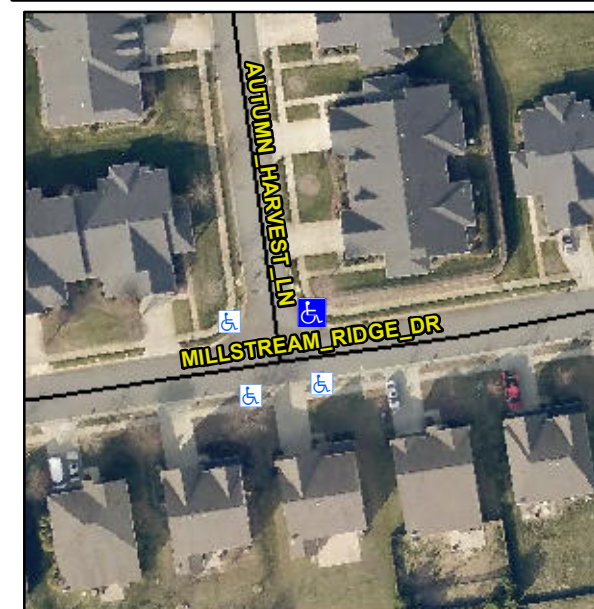
Not Found, R304.2.2, R304.5.3

Compliance	Description	Data	Compliance	Description	Data
N/A	Ramp Length (in)	47.0	No	Ramp Slope (%)	8.7
Yes	Ramp Width (in)	48.0	No	Ramp XSlope (%)	7.3
N/A	Flare Type LT	N/A	N/A	Flare Type RT	N/A
N/A	Flare Slope LT (%)	N/A	N/A	Flare Slope RT (%)	N/A
N/A	Flare Traversable LT?	N/A	N/A	Flare Traversable RT?	N/A
N/A	Landing Length (in)	N/A	N/A	DWS Provided?	N/A
N/A	Landing Width (in)	N/A	N/A	DWS Contrast?	N/A
N/A	Landing Slope (%)	N/A	N/A	DWS Length (in)	N/A
N/A	Landing X Slope (%)	N/A	N/A	DWS Full Width?	N/A
N/A	Landing Curb? (Y/N)	N/A	N/A	DWS Offset (in)	N/A
N/A	Shared Landing?	N/A			
N/A	Gutter Ponding?	N/A	N/A	Gutter Slope (%)	N/A
N/A	Gutter Lip Ht (in)	N/A	N/A	Gutter X Slope (%)	N/A
N/A	Painted X Walk1?	No	N/A	Painted X Walk2?	No
	X Walk 1 Direction	To W		X Walk 2 Direction	To S
N/A	X Walk 1 Width (in)	N/A	N/A	X Walk 2 Width (in)	N/A
	X Walk 1 Slope (%)	2.7		X Walk 2 Slope (%)	5.8
	X Walk 1 X Slope (%)	6.1		X Walk 2 X Slope (%)	3.1

Remove & Replace Curb Ramp With Two New Directional Ramps or Equivalent.
