Access Compliance Report
Public Rights-of-Way
(Curb Ramps)

Intersection ID: 46783	**Main Street:** WINTER_VIEW_CT	**Cross Street:** DOMINION_VILLAGE_DR	**Location:** SE
ADA ID: A9E2DF2B85C9	**Ramp Type:** BlendTrans1	**Initial Pass/Fail:** Pass **Overall Compliance:** No	**Severity Score:** 12.75

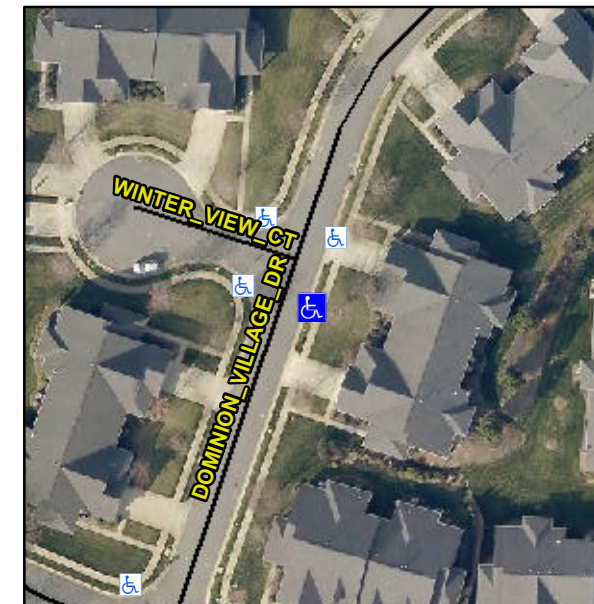
Not Found, R304.5.1, R304.2.1, R305.1.4, R304.5.4

Compliance	Description	Data	Compliance	Description	Data
N/A	Ramp Length (in)	46.5	Yes	BlendTrans Slope (%)	4.5
No	Ramp Width (in)	47.5	Yes	BlendTrans XSlope (%)	0.1
N/A	Flare Type LT	Sloped	N/A	Flare Type RT	Sloped
N/A	Flare Slope LT (%)	0.8	N/A	Flare Slope RT (%)	4.4
N/A	Flare Traversable LT?	No	N/A	Flare Traversable RT?	No
No	Landing Length (in)	47.0	Yes	DWS Provided?	Yes
No	Landing Width (in)	47.5	Yes	DWS Contrast?	Yes
Yes	Landing Slope (%)	1.3	Yes	DWS Length (in)	24.0
Yes	Landing X Slope (%)	0.4	No	DWS Full Width?	No
N/A	Landing Curb? (Y/N)	No	Yes	DWS Offset (in)	1.0
N/A	Shared Landing?	No			
Yes	Gutter Ponding?	No	No	Gutter Slope (%)	9.1
Yes	Gutter Lip Ht (in)	0.0	Yes	Gutter X Slope (%)	1.6
N/A	Painted X Walk1?	No	N/A	Painted X Walk2?	N/A
	X Walk 1 Direction	To W		X Walk 2 Direction	N/A
	X Walk 1 Width (in)	N/A		X Walk 2 Width (in)	N/A
	X Walk 1 Slope (%)	6.2		X Walk 2 Slope (%)	N/A
	X Walk 1 X Slope (%)	1.8		X Walk 2 X Slope (%)	N/A

N/A	Ramp inside XWalk1?	N/A	N/A	Ramp inside XWalk2?	N/A
	Road Slope (%)	1.8		Clear Space?	Yes
	Road X Slope (%)	6.2	N/A	Clear Space to XWalk (in)	N/A
Yes	Any Obstructions?	No	Yes	Storm Grate/Utility Hazard?	No
	Obstruction Type			Storm Grate/Utility Type	
		N/A			N/A
			Yes	Surface Condition? (G/P)	Good
			No	Curb Slope (%)	14.6

Remove & Replace Curb Ramp With Two New Directional Ramps or Equivalent. Remove & Replace Gutter.
