Access Compliance Report

## Public Rights-of-Way
(Curb Ramps)

Intersection ID: 31180	Main Street: SPRING_PARK_DR	Cross Street: BARBEE_DR	Location:	SE
ADA ID: ABC03ECE3CBE	Ramp Type: PerpDiag	Initial Pass/Fail: Fail	Overall Compliance: No	Severity Score: 10

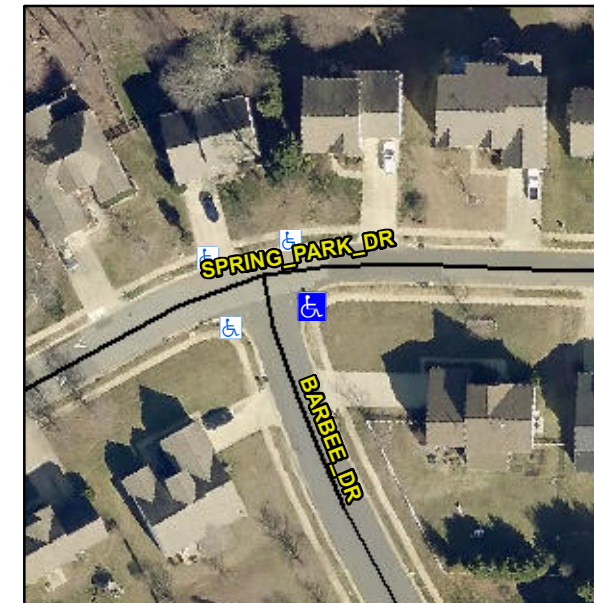
Not Found, R304.5.1, R304.5.3

Compliance	Description	Data	Compliance	Description	Data
N/A	Ramp Length (in)	48.0	Yes	Ramp Slope (%)	5.2
No	Ramp Width (in)	37.0	No	Ramp XSlope (%)	3.3
N/A	Flare Type LT	N/A	N/A	Flare Type RT	N/A
N/A	Flare Slope LT (%)	N/A	N/A	Flare Slope RT (%)	N/A
N/A	Flare Traversable LT?	N/A	N/A	Flare Traversable RT?	N/A
N/A	Landing Length (in)	N/A	N/A	DWS Provided?	N/A
N/A	Landing Width (in)	N/A	N/A	DWS Contrast?	N/A
N/A	Landing Slope (%)	N/A	N/A	DWS Length (in)	N/A
N/A	Landing X Slope (%)	N/A	N/A	DWS Full Width?	N/A
N/A	Landing Curb? (Y/N)	N/A	N/A	DWS Offset (in)	N/A
N/A	Shared Landing?	N/A			
N/A	Gutter Ponding?	N/A	N/A	Gutter Slope (%)	N/A
N/A	Gutter Lip Ht (in)	N/A	N/A	Gutter X Slope (%)	N/A
N/A	Painted X Walk1?	No	N/A	Painted X Walk2?	No
	X Walk 1 Direction	To N		X Walk 2 Direction	To W
N/A	X Walk 1 Width (in)	N/A	N/A	X Walk 2 Width (in)	N/A
	X Walk 1 Slope (%)	1.7		X Walk 2 Slope (%)	3.8
	X Walk 1 X Slope (%)	4.4		X Walk 2 X Slope (%)	2.2

Remove & Replace Curb Ramp With Two New Directional Ramps or Equivalent.
