Access Compliance Report
Public Rights-of-Way
(Curb Ramps)

Intersection ID: 8389	Main Street: N_LINWOOD_AV	Cross Street: ROZZELLES_FERRY_RD	Location:	SE
ADA ID: AC473AE01C64	Ramp Type: Perp	Initial Pass/Fail: Fail	Overall Compliance: No	Severity Score: 35

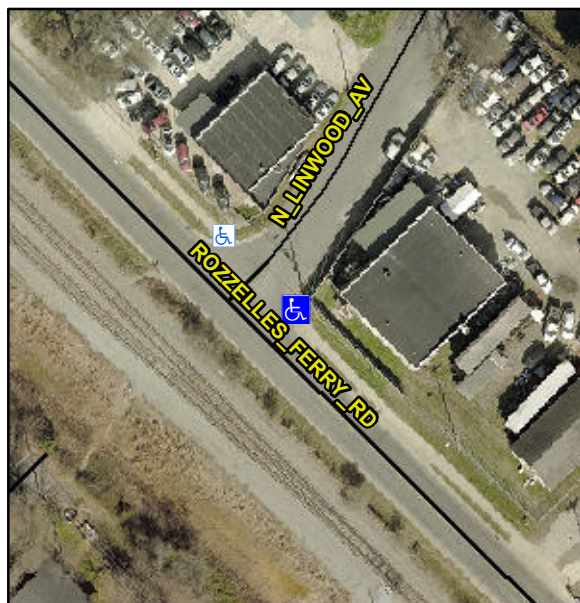
Not Found, R304.5.1, R304.2.2, R304.5.3

Compliance	Description	Data	Compliance	Description	Data
N/A	Ramp Length (in)	30.0	No	Ramp Slope (%)	13.6
No	Ramp Width (in)	40.0	No	Ramp XSlope (%)	4.6
N/A	Flare Type LT	N/A	N/A	Flare Type RT	N/A
N/A	Flare Slope LT (%)	N/A	N/A	Flare Slope RT (%)	N/A
N/A	Flare Traversable LT?	N/A	N/A	Flare Traversable RT?	N/A
N/A	Landing Length (in)	N/A	N/A	DWS Provided?	N/A
N/A	Landing Width (in)	N/A	N/A	DWS Contrast?	N/A
N/A	Landing Slope (%)	N/A	N/A	DWS Length (in)	N/A
N/A	Landing X Slope (%)	N/A	N/A	DWS Full Width?	N/A
N/A	Landing Curb? (Y/N)	N/A	N/A	DWS Offset (in)	N/A
N/A	Shared Landing?	N/A			
N/A	Gutter Ponding?	N/A	N/A	Gutter Slope (%)	N/A
N/A	Gutter Lip Ht (in)	N/A	N/A	Gutter X Slope (%)	N/A
N/A	Painted X Walk1?	No	N/A	Painted X Walk2?	N/A
	X Walk 1 Direction	To NW		X Walk 2 Direction	N/A
N/A	X Walk 1 Width (in)	N/A	N/A	X Walk 2 Width (in)	N/A
	X Walk 1 Slope (%)	2.9		X Walk 2 Slope (%)	N/A
	X Walk 1 X Slope (%)	4.7		X Walk 2 X Slope (%)	N/A

Remove & Replace Entire Ramp.
