Access Compliance Report

# Public Rights-of-Way
(Curb Ramps)

Intersection ID: 9543	Main Street: W_30TH_ST	Cross Street: BELLEFONTE_DR	Location:	SW
ADA ID: AC99E6727963	Ramp Type: PerpDiag	Initial Pass/Fail: Fail	Overall Compliance: No	Severity Score: 17.5

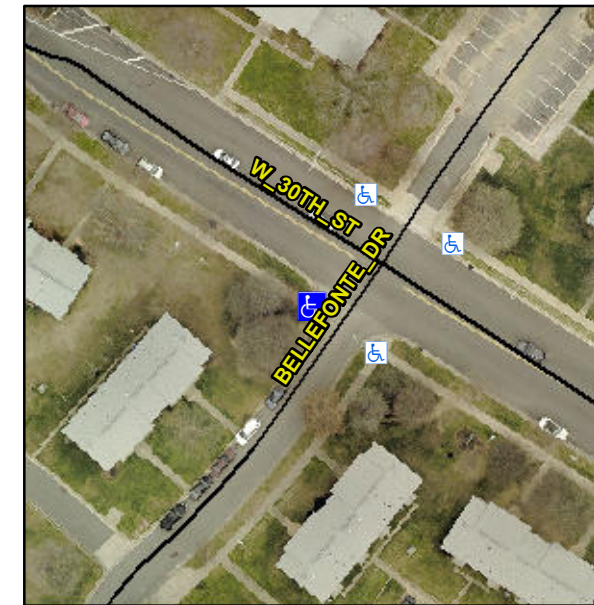
Not Found, R304.5.1

Compliance	Description	Data	Compliance	Description	Data
N/A	Ramp Length (in)	58.0	Yes	Ramp Slope (%)	8.3
No	Ramp Width (in)	32.0	Yes	Ramp XSlope (%)	0.3
N/A	Flare Type LT	N/A	N/A	Flare Type RT	N/A
N/A	Flare Slope LT (%)	N/A	N/A	Flare Slope RT (%)	N/A
N/A	Flare Traversable LT?	N/A	N/A	Flare Traversable RT?	N/A
N/A	Landing Length (in)	N/A	N/A	DWS Provided?	N/A
N/A	Landing Width (in)	N/A	N/A	DWS Contrast?	N/A
N/A	Landing Slope (%)	N/A	N/A	DWS Length (in)	N/A
N/A	Landing X Slope (%)	N/A	N/A	DWS Full Width?	N/A
N/A	Landing Curb? (Y/N)	N/A	N/A	DWS Offset (in)	N/A
N/A	Shared Landing?	N/A			
N/A	Gutter Ponding?	Yes	N/A	Gutter Slope (%)	N/A
N/A	Gutter Lip Ht (in)	N/A	N/A	Gutter X Slope (%)	N/A
N/A	Painted X Walk1?	No	N/A	Painted X Walk2?	No
	X Walk 1 Direction	To SE		X Walk 2 Direction	To NE
N/A	X Walk 1 Width (in)	N/A	N/A	X Walk 2 Width (in)	N/A
	X Walk 1 Slope (%)	2.3		X Walk 2 Slope (%)	1.6
	X Walk 1 X Slope (%)	0.9		X Walk 2 X Slope (%)	0.7

Remove & Replace Curb Ramp With Two New Directional Ramps or Equivalent.
