Access Compliance Report

# Public Rights-of-Way
(Curb Ramps)

Intersection ID: N/A	Main Street: SAWMILL_RACE_DR	Cross Street: SILVERSWORD_DR	Location:	N
ADA ID: ACAE57992743	Ramp Type: Combination2Diag	Initial Pass/Fail: Fail	Overall Compliance: No	Severity Score: 0

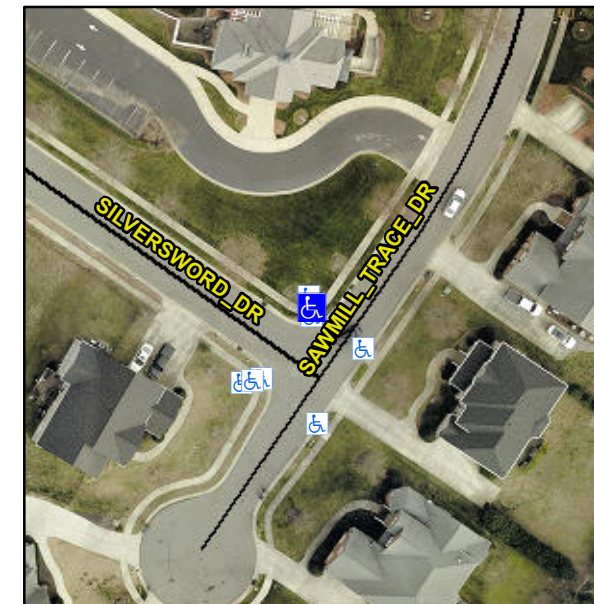
Not Found, R304.5.1, R304.5.3

Compliance	Description	Data	Compliance	Description	Data
N/A	Ramp Length LT (in)	7.0	N/A	Ramp Length RT (in)	7.0
Yes	Ramp Width LT (in)	48.0	No	Ramp Width RT (in)	47.0
Yes	Ramp Slope LT (%)	7.3	Yes	Ramp Slope RT (%)	2.2
Yes	Ramp XSlope LT (%)	1.5	Yes	Ramp XSlope RT (%)	1.3
N/A	Ramp Length (in)	49.0	Yes	Ramp Slope (%)	4.4
Yes	Ramp Width (in)	48.0	No	Ramp XSlope (%)	5.4
N/A	Flare Type LT	N/A	N/A	Flare Type RT	N/A
N/A	Flare Slope LT (%)	N/A	N/A	Flare Slope RT (%)	N/A
N/A	Flare Traversable LT?	N/A	N/A	Flare Traversable RT?	N/A
N/A	Landing Length (in)	N/A	N/A	DWS Provided?	N/A
N/A	Landing Width (in)	N/A	N/A	DWS Contrast?	N/A
N/A	Landing Slope (%)	N/A	N/A	DWS Length (in)	N/A
N/A	Landing X Slope (%)	N/A	N/A	DWS Full Width?	N/A
N/A	Landing Curb? (Y/N)	N/A	N/A	DWS Offset (in)	N/A
N/A	Shared Landing?	N/A			
N/A	Gutter Ponding?	N/A	N/A	Gutter Slope (%)	N/A
N/A	Gutter Lip Ht (in)	N/A	N/A	Gutter X Slope (%)	N/A
N/A	Painted X Walk1?	No	N/A	Painted X Walk2?	No

X Walk 1 Direction	To SW		X Walk 2 Direction	To SE
	X Walk 1 Width (in)	N/A		X Walk 2 Width (in)	N/A
	X Walk 1 Slope (%)	1.8		X Walk 2 Slope (%)	0.9
	X Walk 1 X Slope (%)	2.8		X Walk 2 X Slope (%)	2.4
N/A	Ramp inside XWalk1?	N/A	N/A	Ramp inside XWalk2?	N/A
	Road Slope (%)	3.4		Clear Space?	N/A
	Road X Slope (%)	1.7	N/A	Clear Space to XWalk (in)	N/A
			N/A	Any Obstruction?	N/A
				Obstruction Type	N/A
			N/A	Storm Grate/Utility Hazard?	N/A
				Storm Grate/Utility Type	N/A
			Yes	Surface Condition? (G/P)	Good
				Curb Slope (%)	20.1

Remove & Replace Curb Ramp With Two New Directional Ramps or Equivalent.
