Access Compliance Report
Public Rights-of-Way
(Curb Ramps)

Intersection ID: 30475	Main Street: PLANTERS_ROW_DR	Cross Street: WALKING_STICK_DR	Location:	SW
ADA ID: AD27A3DEE1A4	Ramp Type: PerpDiag	Initial Pass/Fail: Fail	Overall Compliance: No	Severity Score: 25

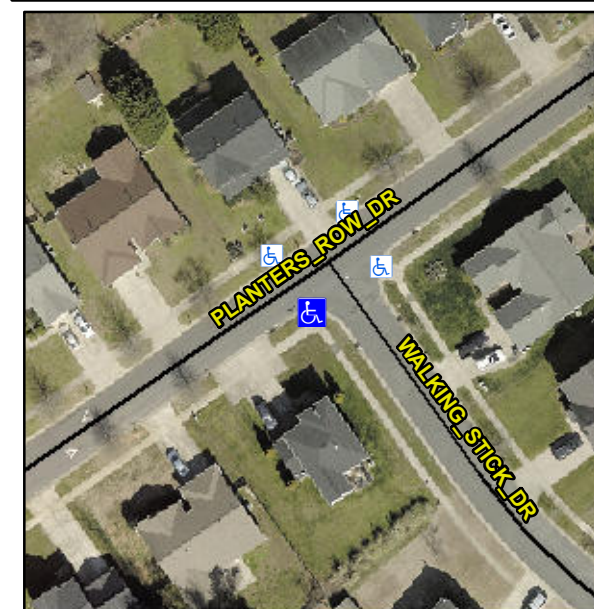
Not Found, R304.5.3

Compliance	Description	Data	Compliance	Description	Data
N/A	Ramp Length (in)	121.0	Yes	Ramp Slope (%)	8.2
Yes	Ramp Width (in)	48.0	No	Ramp XSlope (%)	12.5
N/A	Flare Type LT	N/A	N/A	Flare Type RT	N/A
N/A	Flare Slope LT (%)	N/A	N/A	Flare Slope RT (%)	N/A
N/A	Flare Traversable LT?	N/A	N/A	Flare Traversable RT?	N/A
N/A	Landing Length (in)	N/A	N/A	DWS Provided?	N/A
N/A	Landing Width (in)	N/A	N/A	DWS Contrast?	N/A
N/A	Landing Slope (%)	N/A	N/A	DWS Length (in)	N/A
N/A	Landing X Slope (%)	N/A	N/A	DWS Full Width?	N/A
N/A	Landing Curb? (Y/N)	N/A	N/A	DWS Offset (in)	N/A
N/A	Shared Landing?	N/A			
N/A	Gutter Ponding?	N/A	N/A	Gutter Slope (%)	N/A
N/A	Gutter Lip Ht (in)	N/A	N/A	Gutter X Slope (%)	N/A
N/A	Painted X Walk1?	No	N/A	Painted X Walk2?	No
	X Walk 1 Direction	To NE		X Walk 2 Direction	To NW
N/A	X Walk 1 Width (in)	N/A	N/A	X Walk 2 Width (in)	N/A
	X Walk 1 Slope (%)	3.6		X Walk 2 Slope (%)	1.8
	X Walk 1 X Slope (%)	2.2		X Walk 2 X Slope (%)	3.5

Remove & Replace Curb Ramp With Two New Directional Ramps or Equivalent.
