Access Compliance Report
Public Rights-of-Way
(Curb Ramps)

Intersection ID: 43289	Main Street: ALEXA_RD	Cross Street: BERKELEY_POND_DR	Location: SW
ADA ID: AD36E39DA91B	Ramp Type: PerpDiag	Initial Pass/Fail: Fail	Overall Compliance: No	Severity Score: 33.75

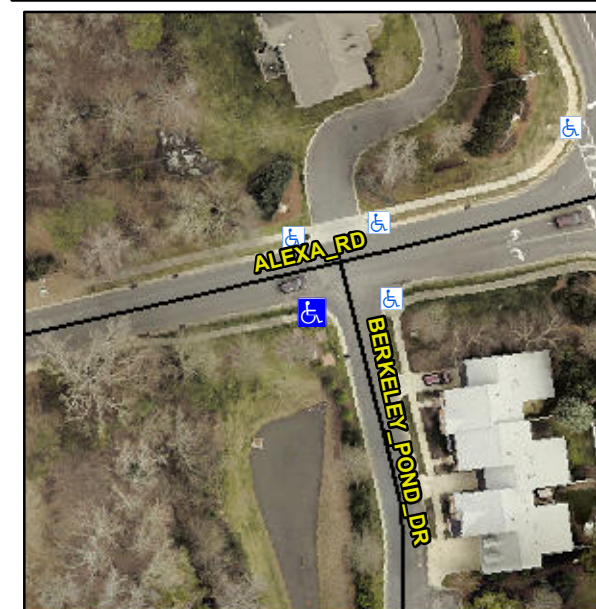
Not Found, R304.5.1, R304.5.3

Compliance	Description	Data	Compliance	Description	Data
N/A	Ramp Length (in)	52.0	Yes	Ramp Slope (%)	5.6
No	Ramp Width (in)	45.0	No	Ramp XSlope (%)	10.6
N/A	Flare Type LT	N/A	N/A	Flare Type RT	N/A
N/A	Flare Slope LT (%)	N/A	N/A	Flare Slope RT (%)	N/A
N/A	Flare Traversable LT?	N/A	N/A	Flare Traversable RT?	N/A
N/A	Landing Length (in)	N/A	N/A	DWS Provided?	N/A
N/A	Landing Width (in)	N/A	N/A	DWS Contrast?	N/A
N/A	Landing Slope (%)	N/A	N/A	DWS Length (in)	N/A
N/A	Landing X Slope (%)	N/A	N/A	DWS Full Width?	N/A
N/A	Landing Curb? (Y/N)	N/A	N/A	DWS Offset (in)	N/A
N/A	Shared Landing?	N/A			
N/A	Gutter Ponding?	N/A	N/A	Gutter Slope (%)	N/A
N/A	Gutter Lip Ht (in)	N/A	N/A	Gutter X Slope (%)	N/A
N/A	Painted X Walk1?	No	N/A	Painted X Walk2?	No
	X Walk 1 Direction	To E		X Walk 2 Direction	To N
N/A	X Walk 1 Width (in)	N/A	N/A	X Walk 2 Width (in)	N/A
	X Walk 1 Slope (%)	1.1		X Walk 2 Slope (%)	0.6
	X Walk 1 X Slope (%)	13.1		X Walk 2 X Slope (%)	6.1

Remove & Replace Curb Ramp With Two New Directional Ramps or Equivalent.
