Access Compliance Report
Public Rights-of-Way
(Curb Ramps)

Intersection ID: 14553	**Main Street: BRIAR_CREEK_RD**	**Cross Street: MONROE_RD**	**Location:**	**NE**
ADA ID: AF1298C4188B	**Ramp Type: Perp**	**Initial Pass/Fail: Fail**	**Overall Compliance: No**	**Severity Score: 22.5**

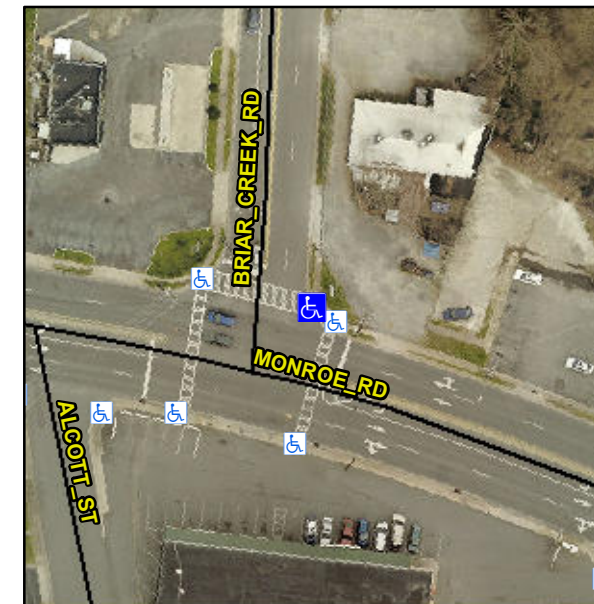
Not Found, R304.5.1, R304.2.2

Compliance	Description	Data	Compliance	Description	Data
N/A	Ramp Length (in)	64.0	No	Ramp Slope (%)	10.6
No	Ramp Width (in)	41.0	Yes	Ramp XSlope (%)	2.4
N/A	Flare Type LT	N/A	N/A	Flare Type RT	N/A
N/A	Flare Slope LT (%)	N/A	N/A	Flare Slope RT (%)	N/A
N/A	Flare Traversable LT?	N/A	N/A	Flare Traversable RT?	N/A
N/A	Landing Length (in)	N/A	N/A	DWS Provided?	N/A
N/A	Landing Width (in)	N/A	N/A	DWS Contrast?	N/A
N/A	Landing Slope (%)	N/A	N/A	DWS Length (in)	N/A
N/A	Landing X Slope (%)	N/A	N/A	DWS Full Width?	N/A
N/A	Landing Curb? (Y/N)	N/A	N/A	DWS Offset (in)	N/A
N/A	Shared Landing?	N/A			
N/A	Gutter Ponding?	N/A	N/A	Gutter Slope (%)	N/A
N/A	Gutter Lip Ht (in)	N/A	N/A	Gutter X Slope (%)	N/A
N/A	Painted X Walk1?	Yes	N/A	Painted X Walk2?	N/A
	X Walk 1 Direction	To NW		X Walk 2 Direction	N/A
N/A	X Walk 1 Width (in)	115.0	N/A	X Walk 2 Width (in)	N/A
	X Walk 1 Slope (%)	3.4		X Walk 2 Slope (%)	N/A
	X Walk 1 X Slope (%)	5.8		X Walk 2 X Slope (%)	N/A

Remove & Replace Entire Ramp.
