Access Compliance Report
Public Rights-of-Way
(Curb Ramps)

Intersection ID: 53159 | **Main Street:** LANGWELL_LN | **Cross Street:** HAMILTON_BRIDGE_RD | **Location:** SE

ADA ID: AF23FC9E3FEE | **Ramp Type:** BlendTrans1 | **Initial Pass/Fail:** Fail | **Overall Compliance:** No | **Severity Score:** 8.75

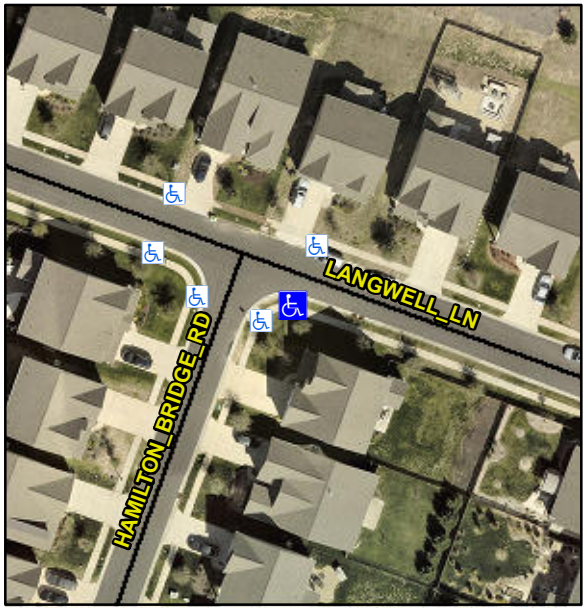
Not Found, R304.5.1

Compliance	Description	Data	Compliance	Description	Data
N/A	Ramp Length (in)	47.0	Yes	BlendTrans Slope (%)	3.7
No	Ramp Width (in)	47.0	Yes	BlendTrans XSlope (%)	0.3
N/A	Flare Type LT	N/A	N/A	Flare Type RT	N/A
N/A	Flare Slope LT (%)	N/A	N/A	Flare Slope RT (%)	N/A
N/A	Flare Traversable LT?	N/A	N/A	Flare Traversable RT?	N/A
N/A	Landing Length (in)	N/A	N/A	DWS Provided?	N/A
N/A	Landing Width (in)	N/A	N/A	DWS Contrast?	N/A
N/A	Landing Slope (%)	N/A	N/A	DWS Length (in)	N/A
N/A	Landing X Slope (%)	N/A	N/A	DWS Full Width?	N/A
N/A	Landing Curb? (Y/N)	N/A	N/A	DWS Offset (in)	N/A
N/A	Shared Landing?	N/A			
N/A	Gutter Ponding?	N/A	N/A	Gutter Slope (%)	N/A
N/A	Gutter Lip Ht (in)	1.0	N/A	Gutter X Slope (%)	N/A
N/A	Painted X Walk1?	No	N/A	Painted X Walk2?	N/A
	X Walk 1 Direction	To NE		X Walk 2 Direction	N/A
	X Walk 1 Width (in)	N/A		X Walk 2 Width (in)	N/A
	X Walk 1 Slope (%)	0.8		X Walk 2 Slope (%)	N/A
	X Walk 1 X Slope (%)	1.2		X Walk 2 X Slope (%)	N/A

N/A	Ramp inside XWalk1?	N/A	N/A	Ramp inside XWalk2?	N/A
	Road Slope (%)	1.2		Clear Space?	N/A
	Road X Slope (%)	0.8	N/A	Clear Space to XWalk (in)	N/A
N/A	Any Obstructions?	N/A	N/A	Storm Grate/Utility Hazard?	N/A
	Obstruction Type			Storm Grate/Utility Type	
		N/A			N/A
			Yes	Surface Condition? (G/P)	Good
			No	Curb Slope (%)	8.0

Remove & Replace Curb Ramp With Two New Directional Ramps or Equivalent.
