Access Compliance Report
Public Rights-of-Way
(Curb Ramps)

Intersection ID: 5075	Main Street: FERNMOSS_CT	Cross Street: HEDGECREST_PL	Location: SE
ADA ID: AF87E1B025AD	Ramp Type: Directional1	Initial Pass/Fail: Fail	Overall Compliance: No	Severity Score: 21.25

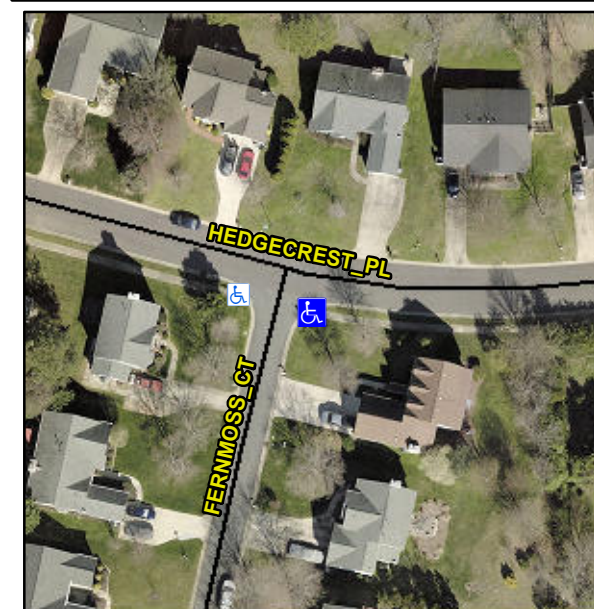
R304.5.1, R304.2.2

Compliance	Description	Data	Compliance	Description	Data
N/A	Ramp Length (in)	56.0	N/A	Grade Break?	N/A
No	Ramp Width (in)	43.5	N/A	Grade Break Slope (%)	0.0
No	Ramp Slope (%)	10.6	N/A	Grade Break XSlope (%)	0.0
Yes	Ramp XSlope (%)	1.5			
N/A	Flare Type LT	N/A	N/A	Flare Type RT	N/A
N/A	Flare Slope LT (%)	N/A	N/A	Flare Slope RT (%)	0.0
N/A	Flare Traversable LT?	N/A	N/A	Flare Traversable RT?	N/A
N/A	Landing Length (in)	0.0	N/A	DWS Provided?	N/A
N/A	Landing Width (in)	0.0	N/A	DWS Contrast?	N/A
N/A	Landing Slope (%)	0.0	N/A	DWS Length (in)	N/A
N/A	Landing X Slope (%)	0.0	N/A	DWS Full Width?	N/A
N/A	Landing Curb? (Y/N)	N/A	N/A	DWS Offset LT (in)	N/A
N/A	Shared Landing?	N/A	N/A	DWS Offset RT (in)	N/A
N/A	Gutter Ponding?	0.0	N/A	Gutter Slope (%)	N/A
N/A	Gutter Lip Ht (in)	0.0	N/A	Gutter X Slope (%)	N/A
N/A	Painted X Walk1?	No		Road Slope (%)	4.7
	X Walk 1 Direction	To W		Road X Slope (%)	5.9
	X Walk 1 Width (in)	N/A		Clear Space?	N/A

X Walk 1 Slope (%)	4.7	N/A	Clear Space to XWalk (in)	N/A
	X Walk 1 X Slope (%)	5.9	N/A	Storm Grate/Utility Hazard?	N/A
N/A	Ramp inside XWalk1?	N/A		Storm Grate/Utility Type	
N/A	Any Obstructions?	N/A			N/A
	Obstruction Type		Yes	Surface Condition? (G/P)	Good
N/A			N/A	Curb Slope (%)	N/A

Remove & Replace Entire Ramp.
