Access Compliance Report

# Public Rights-of-Way
(Curb Ramps)

Intersection ID: 30551	Main Street: EDENDERRY_DR	Cross Street: WEDDINGTON_RD	Location:	SW
ADA ID: B0092DAE3BCB	Ramp Type: Perp	Initial Pass/Fail: Fail	Overall Compliance: No	Severity Score: 10

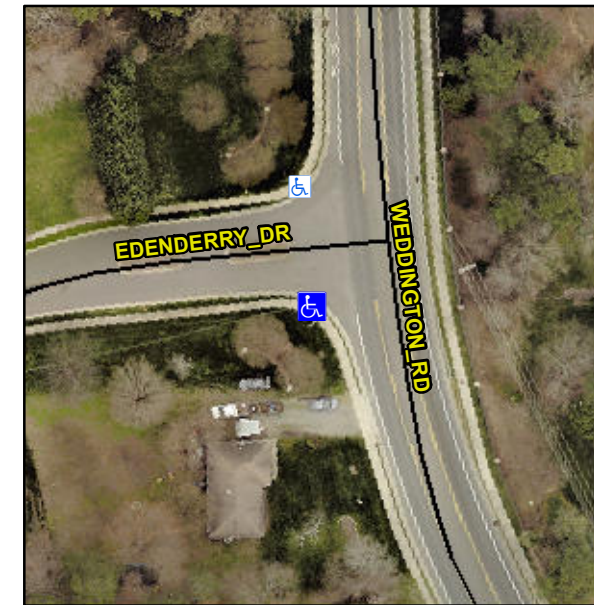
EDENDERRY_DR / WEDDINGTON RD

Not Found, R304.5.1, R304.5.3

Compliance	Description	Data	Compliance	Description	Data
N/A	Ramp Length (in)	76.0	Yes	Ramp Slope (%)	5.3
No	Ramp Width (in)	47.0	No	Ramp XSlope (%)	3.7
N/A	Flare Type LT	N/A	N/A	Flare Type RT	N/A
N/A	Flare Slope LT (%)	N/A	N/A	Flare Slope RT (%)	N/A
N/A	Flare Traversable LT?	N/A	N/A	Flare Traversable RT?	N/A
N/A	Landing Length (in)	N/A	N/A	DWS Provided?	N/A
N/A	Landing Width (in)	N/A	N/A	DWS Contrast?	N/A
N/A	Landing Slope (%)	N/A	N/A	DWS Length (in)	N/A
N/A	Landing X Slope (%)	N/A	N/A	DWS Full Width?	N/A
N/A	Landing Curb? (Y/N)	N/A	N/A	DWS Offset (in)	N/A
N/A	Shared Landing?	N/A			
N/A	Gutter Ponding?	N/A	N/A	Gutter Slope (%)	N/A
N/A	Gutter Lip Ht (in)	N/A	N/A	Gutter X Slope (%)	N/A
N/A	Painted X Walk1?	No	N/A	Painted X Walk2?	N/A
	X Walk 1 Direction	To N		X Walk 2 Direction	N/A
N/A	X Walk 1 Width (in)	N/A	N/A	X Walk 2 Width (in)	N/A
	X Walk 1 Slope (%)	0.0		X Walk 2 Slope (%)	N/A
	X Walk 1 X Slope (%)	4.8		X Walk 2 X Slope (%)	N/A

Remove & Replace Entire Ramp.
