Access Compliance Report
Public Rights-of-Way
(Curb Ramps)

Intersection ID: 15001 **Main Street:** N_DOTGER_AV **Cross Street:** VAIL_AV **Location:** W

ADA ID: B17ED310C2DA **Ramp Type:** Perp **Initial Pass/Fail:** Fail **Overall Compliance:** No **Severity Score:** 12.5

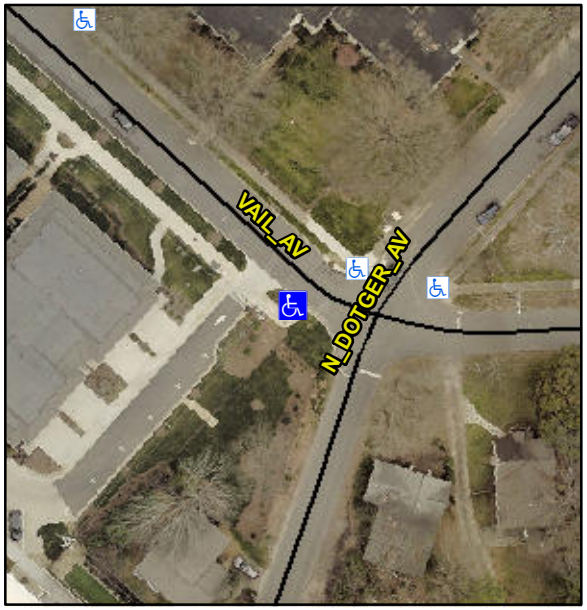
R304.2.2

Compliance	Description	Data	Compliance	Description	Data
N/A	Ramp Length (in)	96.0	No	Ramp Slope (%)	9.6
Yes	Ramp Width (in)	68.0	Yes	Ramp XSlope (%)	1.8
N/A	Flare Type LT	N/A	N/A	Flare Type RT	N/A
N/A	Flare Slope LT (%)	N/A	N/A	Flare Slope RT (%)	N/A
N/A	Flare Traversable LT?	N/A	N/A	Flare Traversable RT?	N/A
N/A	Landing Length (in)	N/A	N/A	DWS Provided?	N/A
N/A	Landing Width (in)	N/A	N/A	DWS Contrast?	N/A
N/A	Landing Slope (%)	N/A	N/A	DWS Length (in)	N/A
N/A	Landing X Slope (%)	N/A	N/A	DWS Full Width?	N/A
N/A	Landing Curb? (Y/N)	N/A	N/A	DWS Offset (in)	N/A
N/A	Shared Landing?	N/A			
N/A	Gutter Ponding?	N/A	N/A	Gutter Slope (%)	N/A
N/A	Gutter Lip Ht (in)	N/A	N/A	Gutter X Slope (%)	N/A
N/A	Painted X Walk1?	No	N/A	Painted X Walk2?	N/A
	X Walk 1 Direction	To NE		X Walk 2 Direction	N/A
N/A	X Walk 1 Width (in)	N/A	N/A	X Walk 2 Width (in)	N/A
	X Walk 1 Slope (%)	0.5		X Walk 2 Slope (%)	N/A
	X Walk 1 X Slope (%)	3.0		X Walk 2 X Slope (%)	N/A

Remove & Replace Entire Ramp.
