Access Compliance Report
Public Rights-of-Way
(Curb Ramps)

Intersection ID: 5897	Main Street: FOREST_POND_DR	Cross Street: PINK_DOGWOOD_LN	Location:	E
ADA ID: B379C24D6CBE	Ramp Type: Perp	Initial Pass/Fail: Fail	Overall Compliance: No	Severity Score: 10

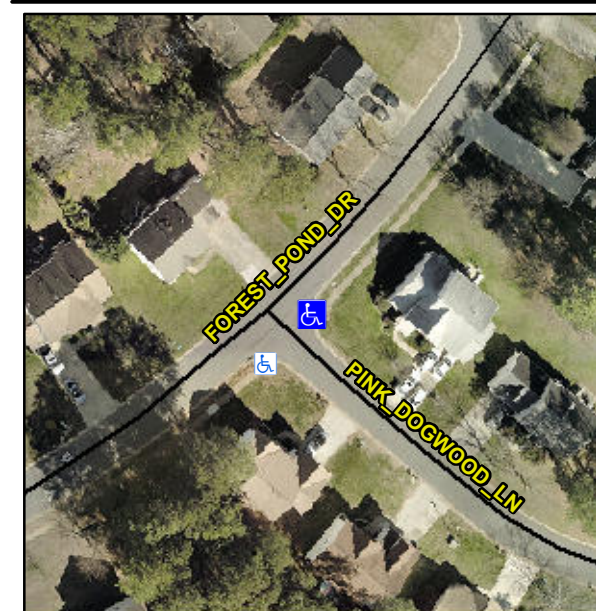
Not Found, R304.5.1, R304.5.3

Compliance	Description	Data	Compliance	Description	Data
N/A	Ramp Length (in)	95.0	Yes	Ramp Slope (%)	5.8
No	Ramp Width (in)	42.0	No	Ramp XSlope (%)	2.8
N/A	Flare Type LT	N/A	N/A	Flare Type RT	N/A
N/A	Flare Slope LT (%)	N/A	N/A	Flare Slope RT (%)	N/A
N/A	Flare Traversable LT?	N/A	N/A	Flare Traversable RT?	N/A
N/A	Landing Length (in)	N/A	N/A	DWS Provided?	N/A
N/A	Landing Width (in)	N/A	N/A	DWS Contrast?	N/A
N/A	Landing Slope (%)	N/A	N/A	DWS Length (in)	N/A
N/A	Landing X Slope (%)	N/A	N/A	DWS Full Width?	N/A
N/A	Landing Curb? (Y/N)	N/A	N/A	DWS Offset (in)	N/A
N/A	Shared Landing?	N/A			
N/A	Gutter Ponding?	N/A	N/A	Gutter Slope (%)	N/A
N/A	Gutter Lip Ht (in)	N/A	N/A	Gutter X Slope (%)	N/A
N/A	Painted X Walk1?	No	N/A	Painted X Walk2?	N/A
	X Walk 1 Direction	To SW		X Walk 2 Direction	N/A
N/A	X Walk 1 Width (in)	N/A	N/A	X Walk 2 Width (in)	N/A
	X Walk 1 Slope (%)	0.6		X Walk 2 Slope (%)	N/A
	X Walk 1 X Slope (%)	4.5		X Walk 2 X Slope (%)	N/A

N/A	Ramp inside XWalk1?	N/A	N/A	Ramp inside XWalk2?	N/A
	Road Slope (%)	N/A	N/A	Clear Space?	N/A
	Road X Slope (%)	N/A	N/A	Clear Space to XWalk (in)	N/A
N/A	Any Obstructions?	N/A	N/A	Storm Grate/Utility Hazard?	N/A
	Obstruction Type			Storm Grate/Utility Type	
		N/A			N/A
			Yes	Surface Condition? (G/P)	Good

Remove & Replace Entire Ramp.
