Access Compliance Report
Public Rights-of-Way
(Curb Ramps)

Intersection ID: N/A	Main Street: GERALD_DR	Cross Street: SULLIVANS_TRACE_DR	Location:	SW
ADA ID: B3A7071A1648	Ramp Type: PerpDiag	Initial Pass/Fail: Fail	Overall Compliance: No	Severity Score: 33.75

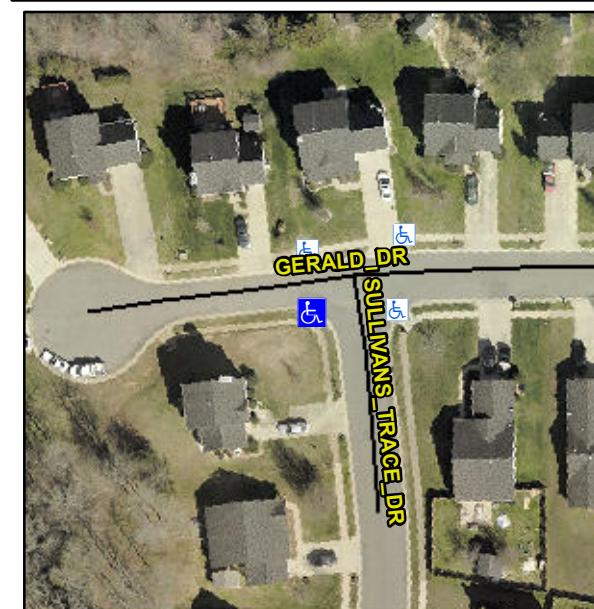
R304.5.1, R304.5.3

Compliance	Description	Data	Compliance	Description	Data
N/A	Ramp Length (in)	51.0	Yes	Ramp Slope (%)	8.2
No	Ramp Width (in)	41.0	No	Ramp XSlope (%)	9.2
N/A	Flare Type LT	N/A	N/A	Flare Type RT	N/A
N/A	Flare Slope LT (%)	N/A	N/A	Flare Slope RT (%)	N/A
N/A	Flare Traversable LT?	N/A	N/A	Flare Traversable RT?	N/A
N/A	Landing Length (in)	N/A	N/A	DWS Provided?	N/A
N/A	Landing Width (in)	N/A	N/A	DWS Contrast?	N/A
N/A	Landing Slope (%)	N/A	N/A	DWS Length (in)	N/A
N/A	Landing X Slope (%)	N/A	N/A	DWS Full Width?	N/A
N/A	Landing Curb? (Y/N)	N/A	N/A	DWS Offset (in)	N/A
N/A	Shared Landing?	N/A			
N/A	Gutter Ponding?	N/A	N/A	Gutter Slope (%)	N/A
N/A	Gutter Lip Ht (in)	N/A	N/A	Gutter X Slope (%)	N/A
N/A	Painted X Walk1?	No	N/A	Painted X Walk2?	No
	X Walk 1 Direction	To E		X Walk 2 Direction	To N
N/A	X Walk 1 Width (in)	N/A	N/A	X Walk 2 Width (in)	N/A
	X Walk 1 Slope (%)	2.0		X Walk 2 Slope (%)	3.0
	X Walk 1 X Slope (%)	3.7		X Walk 2 X Slope (%)	3.3

N/A	Ramp inside XWalk1?	N/A	N/A	Ramp inside XWalk2?	N/A
	Road Slope (%)	4.7	N/A	Clear Space?	N/A
	Road X Slope (%)	1.4	N/A	Clear Space to XWalk (in)	N/A
N/A	Any Obstructions?	N/A	N/A	Storm Grate/Utility Hazard?	N/A
	Obstruction Type			Storm Grate/Utility Type	
N/A					N/A
			Yes	Surface Condition? (G/P)	Good

Remove & Replace Curb Ramp With Two New Directional Ramps or Equivalent.
