# Access Compliance Report
Public Rights-of-Way
(Curb Ramps)

Intersection ID: 4679	Main Street: HERITAGE_POINTE_RD	Cross Street: US_29_ACCESS_RD	Location: N
ADA ID: B4299BAB6623	Ramp Type: Perp	Initial Pass/Fail: Fail	Overall Compliance: No	Severity Score: 46.25

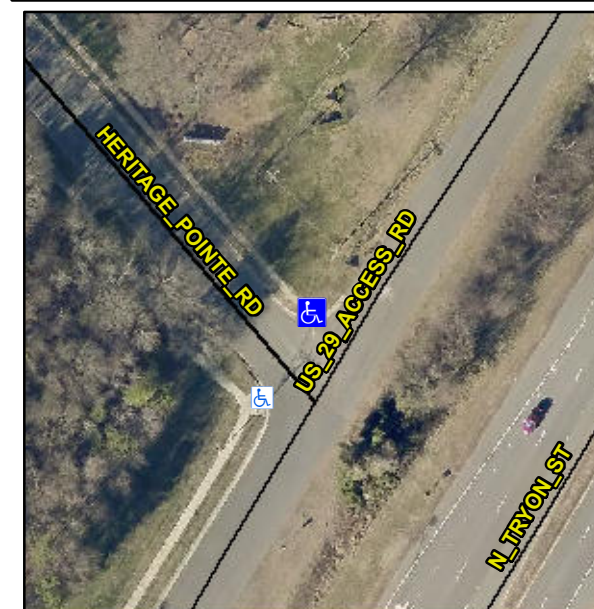
R304.5.1, R304.2.2, R304.5.3

Compliance	Description	Data	Compliance	Description	Data
N/A	Ramp Length (in)	103.0	No	Ramp Slope (%)	20.0
No	Ramp Width (in)	36.0	No	Ramp XSlope (%)	6.4
N/A	Flare Type LT	N/A	N/A	Flare Type RT	N/A
N/A	Flare Slope LT (%)	N/A	N/A	Flare Slope RT (%)	N/A
N/A	Flare Traversable LT?	N/A	N/A	Flare Traversable RT?	N/A
N/A	Landing Length (in)	N/A	N/A	DWS Provided?	N/A
N/A	Landing Width (in)	N/A	N/A	DWS Contrast?	N/A
N/A	Landing Slope (%)	N/A	N/A	DWS Length (in)	N/A
N/A	Landing X Slope (%)	N/A	N/A	DWS Full Width?	N/A
N/A	Landing Curb? (Y/N)	N/A	N/A	DWS Offset (in)	N/A
N/A	Shared Landing?	N/A			
N/A	Gutter Ponding?	N/A	N/A	Gutter Slope (%)	N/A
N/A	Gutter Lip Ht (in)	N/A	N/A	Gutter X Slope (%)	N/A
N/A	Painted X Walk1?	No	N/A	Painted X Walk2?	N/A
	X Walk 1 Direction	To SW		X Walk 2 Direction	N/A
N/A	X Walk 1 Width (in)	N/A	N/A	X Walk 2 Width (in)	N/A
	X Walk 1 Slope (%)	3.1		X Walk 2 Slope (%)	N/A
	X Walk 1 X Slope (%)	1.8		X Walk 2 X Slope (%)	N/A

Remove & Replace Entire Ramp.
