Access Compliance Report
Public Rights-of-Way
(Curb Ramps)

Intersection ID: 32311	**Main Street:** LAUREL_WALK_CT	**Cross Street:** NEW_PROVIDENCE_LN	**Location:** SE
ADA ID: B540CD732B60	**Ramp Type:** PerpDiag	**Initial Pass/Fail:** Fail	**Overall Compliance:** No	**Severity Score:** 22.5

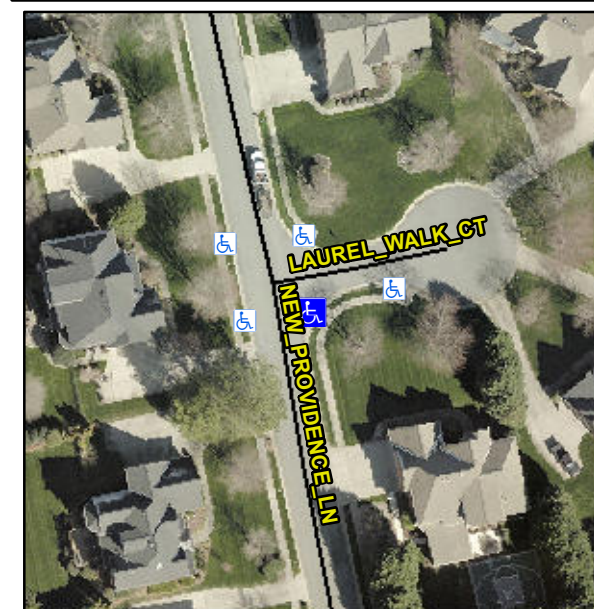
Not Found, R304.5.1, R304.2.2, R304.5.3

Compliance	Description	Data	Compliance	Description	Data
N/A	Ramp Length (in)	48.0	No	Ramp Slope (%)	9.0
No	Ramp Width (in)	43.0	No	Ramp XSlope (%)	2.7
N/A	Flare Type LT	N/A	N/A	Flare Type RT	N/A
N/A	Flare Slope LT (%)	N/A	N/A	Flare Slope RT (%)	N/A
N/A	Flare Traversable LT?	N/A	N/A	Flare Traversable RT?	N/A
N/A	Landing Length (in)	N/A	N/A	DWS Provided?	N/A
N/A	Landing Width (in)	N/A	N/A	DWS Contrast?	N/A
N/A	Landing Slope (%)	N/A	N/A	DWS Length (in)	N/A
N/A	Landing X Slope (%)	N/A	N/A	DWS Full Width?	N/A
N/A	Landing Curb? (Y/N)	N/A	N/A	DWS Offset (in)	N/A
N/A	Shared Landing?	N/A			
N/A	Gutter Ponding?	N/A	N/A	Gutter Slope (%)	N/A
N/A	Gutter Lip Ht (in)	0.5	N/A	Gutter X Slope (%)	N/A
N/A	Painted X Walk1?	No	N/A	Painted X Walk2?	No
	X Walk 1 Direction	To N		X Walk 2 Direction	To W
N/A	X Walk 1 Width (in)	N/A	N/A	X Walk 2 Width (in)	N/A
	X Walk 1 Slope (%)	1.5		X Walk 2 Slope (%)	2.3
	X Walk 1 X Slope (%)	0.9		X Walk 2 X Slope (%)	2.3

Remove & Replace Curb Ramp With Two New Directional Ramps or Equivalent.
