# Access Compliance Report
Public Rights-of-Way
(Curb Ramps)

Intersection ID: 49790   **Main Street:** FESCUE_CT   **Cross Street:** BARLEY_LN   **Location:** NW

ADA ID: B5793E3E984F   **Ramp Type:** Perp   **Initial Pass/Fail:** Pass   **Overall Compliance:** No   **Severity Score:** 5.25

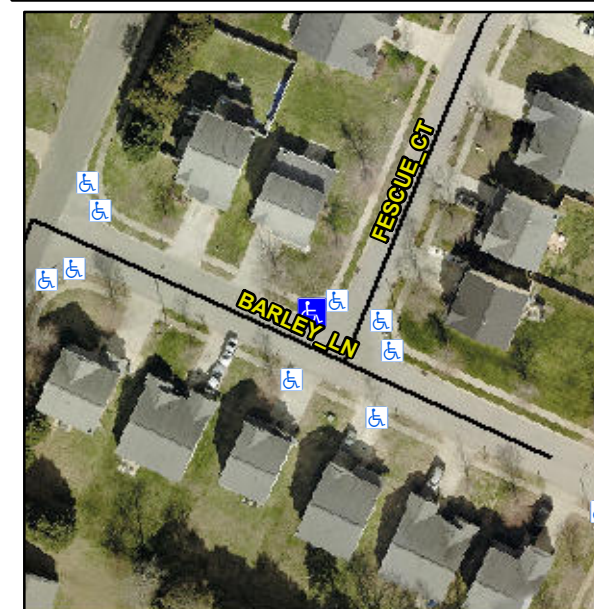
**Not Found, R304.5.3, R304.2.1,
R304.5.4**

Compliance	Description	Data	Compliance	Description	Data
N/A	Ramp Length (in)	24.5	Yes	Ramp Slope (%)	6.5
Yes	Ramp Width (in)	48.0	No	Ramp XSlope (%)	4.0
N/A	Flare Type LT	Sloped	N/A	Flare Type RT	N/A
N/A	Flare Slope LT (%)	4.9	Yes	Flare Slope RT (%)	1.8
N/A	Flare Traversable LT?	Yes	N/A	Flare Traversable RT?	Yes
Yes	Landing Length (in)	69.5	Yes	DWS Provided?	Yes
No	Landing Width (in)	47.0	Yes	DWS Contrast?	Yes
Yes	Landing Slope (%)	1.1	Yes	DWS Length (in)	24.5
No	Landing X Slope (%)	3.5	Yes	DWS Full Width?	Yes
N/A	Landing Curb? (Y/N)	No	Yes	DWS Offset (in)	1.5
N/A	Shared Landing?	No			
Yes	Gutter Ponding?	No	No	Gutter Slope (%)	8.1
Yes	Gutter Lip Ht (in)	0.0	No	Gutter X Slope (%)	3.4
N/A	Painted X Walk1?	No	N/A	Painted X Walk2?	N/A
	X Walk 1 Direction	To S		X Walk 2 Direction	N/A
N/A	X Walk 1 Width (in)	N/A	N/A	X Walk 2 Width (in)	N/A
	X Walk 1 Slope (%)	4.2		X Walk 2 Slope (%)	N/A
	X Walk 1 X Slope (%)	0.3		X Walk 2 X Slope (%)	N/A

N/A	Ramp inside XWalk1?	N/A	N/A	Ramp inside XWalk2?	N/A
	Road Slope (%)	N/A	N/A	Clear Space?	Yes
	Road X Slope (%)	N/A	N/A	Clear Space to XWalk (in)	N/A
Yes	Any Obstructions?	No	Yes	Storm Grate/Utility Hazard?	No
	Obstruction Type			Storm Grate/Utility Type	
N/A					N/A
			Yes	Surface Condition? (G/P)	Good

**Remove & Replace Entire Ramp.
Remove & Replace Gutter.**
