Access Compliance Report

## Public Rights-of-Way
(Curb Ramps)

Intersection ID: 10036601	Main Street: RUSHMORE_DR	Cross Street: N/A	Location:	S
ADA ID: B6B20125C6A5	Ramp Type: PerpDiag	Initial Pass/Fail: Fail	Overall Compliance: No	Severity Score: 22.5

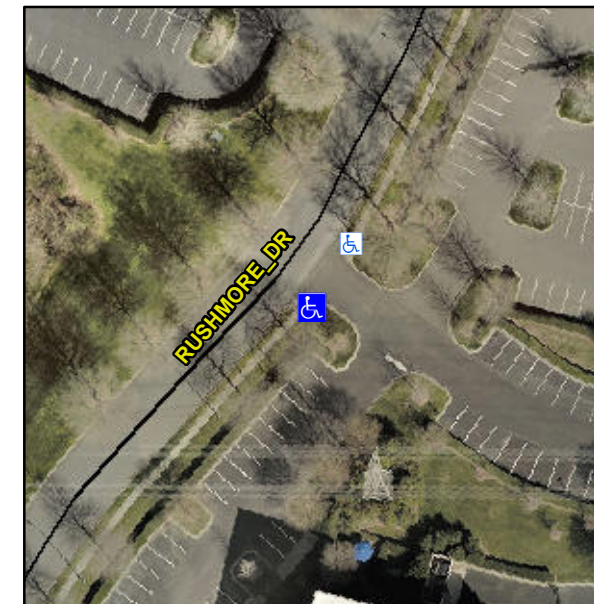
Not Found, R304.5.1, R304.2.2, R304.5.3

Compliance	Description	Data	Compliance	Description	Data
N/A	Ramp Length (in)	61.0	No	Ramp Slope (%)	9.2
No	Ramp Width (in)	39.0	No	Ramp XSlope (%)	4.2
N/A	Flare Type LT	N/A	N/A	Flare Type RT	N/A
N/A	Flare Slope LT (%)	N/A	N/A	Flare Slope RT (%)	N/A
N/A	Flare Traversable LT?	N/A	N/A	Flare Traversable RT?	N/A
N/A	Landing Length (in)	N/A	N/A	DWS Provided?	N/A
N/A	Landing Width (in)	N/A	N/A	DWS Contrast?	N/A
N/A	Landing Slope (%)	N/A	N/A	DWS Length (in)	N/A
N/A	Landing X Slope (%)	N/A	N/A	DWS Full Width?	N/A
N/A	Landing Curb? (Y/N)	N/A	N/A	DWS Offset (in)	N/A
N/A	Shared Landing?	N/A			
N/A	Gutter Ponding?	N/A	N/A	Gutter Slope (%)	N/A
N/A	Gutter Lip Ht (in)	N/A	N/A	Gutter X Slope (%)	N/A
N/A	Painted X Walk1?	No	N/A	Painted X Walk2?	No
	X Walk 1 Direction	To NE		X Walk 2 Direction	To NW
N/A	X Walk 1 Width (in)	N/A	N/A	X Walk 2 Width (in)	N/A
	X Walk 1 Slope (%)	0.4		X Walk 2 Slope (%)	2.1
	X Walk 1 X Slope (%)	6.8		X Walk 2 X Slope (%)	1.6

Remove & Replace Curb Ramp With Two New Directional Ramps or Equivalent.
