# Access Compliance Report
## Public Rights-of-Way
## (Curb Ramps)

| **Intersection ID:** 52622 | **Main Street:** HERITAGE_POND_DR | **Cross Street:** ALEXANDER_COMMONS_DR | **Location:** N |
| **ADA ID:** B74F1E2B15BD | **Ramp Type:** Perp | **Initial Pass/Fail:** Fail | **Overall Compliance:** No | **Severity Score:** 26.25 |

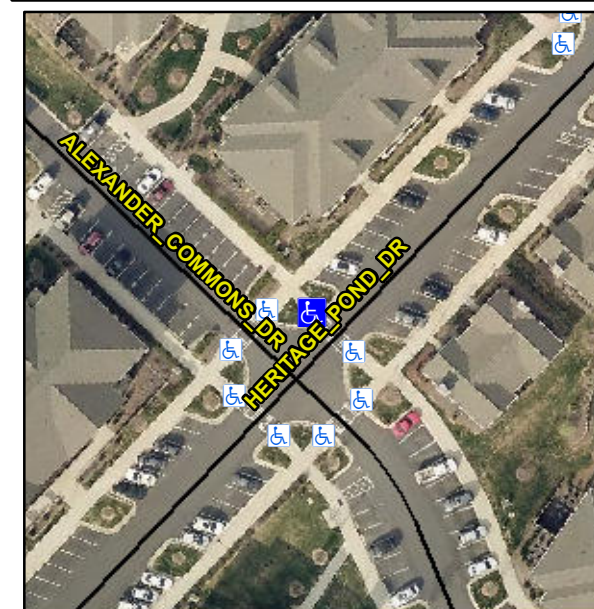
**R304.2.2, R304.5.3**

| Compliance | Description | Data | Compliance | Description | Data |
|---|---|---|---|---|---|
| N/A | Ramp Length (in) | 97.5 | No | Ramp Slope (%) | 15.0 |
| Yes | Ramp Width (in) | 81.5 | No | Ramp XSlope (%) | 2.8 |

**Remove & Replace Entire Ramp.**
