Access Compliance Report

# Public Rights-of-Way
(Curb Ramps)

Intersection ID: 17204	Main Street: PROVIDENCE_RD	Cross Street: VERNON_DR	Location:	NE
ADA ID: B7BA88D7C032	Ramp Type: PerpDiag	Initial Pass/Fail: Fail	Overall Compliance: No	Severity Score: 12.5

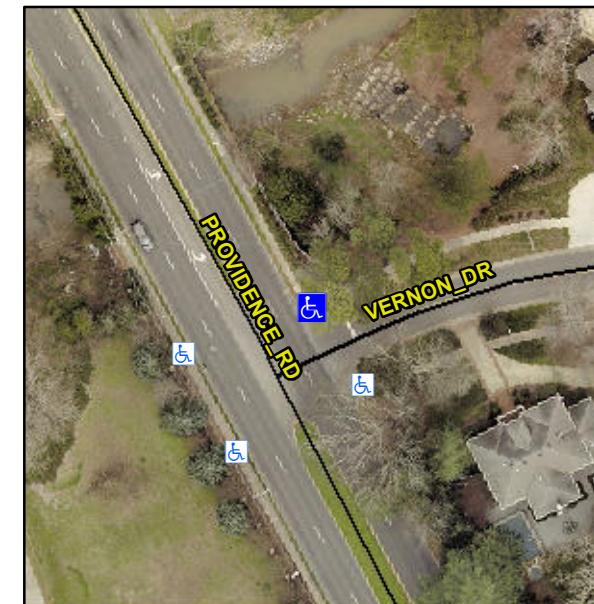
Not Found, R304.5.3

Compliance	Description	Data	Compliance	Description	Data
N/A	Ramp Length (in)	104.0	Yes	Ramp Slope (%)	5.8
Yes	Ramp Width (in)	48.0	No	Ramp XSlope (%)	5.1
N/A	Flare Type LT	N/A	N/A	Flare Type RT	N/A
N/A	Flare Slope LT (%)	N/A	N/A	Flare Slope RT (%)	N/A
N/A	Flare Traversable LT?	N/A	N/A	Flare Traversable RT?	N/A
N/A	Landing Length (in)	N/A	N/A	DWS Provided?	N/A
N/A	Landing Width (in)	N/A	N/A	DWS Contrast?	N/A
N/A	Landing Slope (%)	N/A	N/A	DWS Length (in)	N/A
N/A	Landing X Slope (%)	N/A	N/A	DWS Full Width?	N/A
N/A	Landing Curb? (Y/N)	N/A	N/A	DWS Offset (in)	N/A
N/A	Shared Landing?	N/A			
N/A	Gutter Ponding?	N/A	N/A	Gutter Slope (%)	N/A
N/A	Gutter Lip Ht (in)	N/A	N/A	Gutter X Slope (%)	N/A
N/A	Painted X Walk1?	No	N/A	Painted X Walk2?	No
	X Walk 1 Direction	To SW		X Walk 2 Direction	To SE
N/A	X Walk 1 Width (in)	N/A	N/A	X Walk 2 Width (in)	N/A
	X Walk 1 Slope (%)	4.8		X Walk 2 Slope (%)	9.0
	X Walk 1 X Slope (%)	5.2		X Walk 2 X Slope (%)	1.6

Remove & Replace Curb Ramp With Two New Directional Ramps or Equivalent.
