Access Compliance Report
Public Rights-of-Way
(Curb Ramps)

Intersection ID: 10023803	Main Street: COLONY_RD	Cross Street: N/A	Location:	SW
ADA ID: B91E1F857102	Ramp Type: PerpDiag	Initial Pass/Fail: Fail	Overall Compliance: No	Severity Score: 12.5

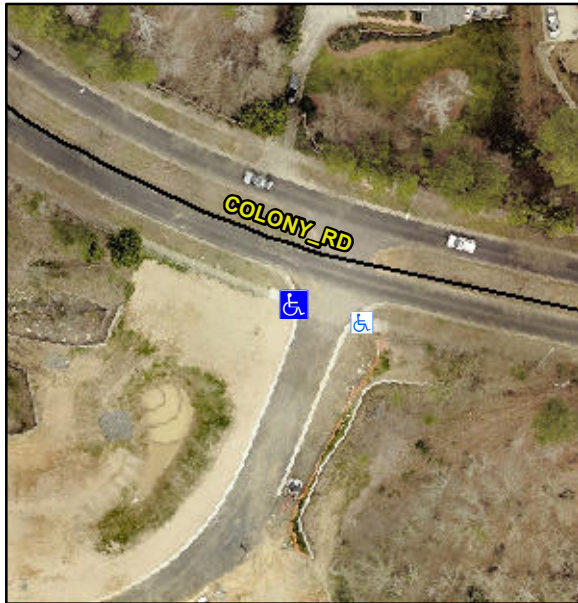
Not Found, R304.2.2

Compliance	Description	Data	Compliance	Description	Data
N/A	Ramp Length (in)	68.0	No	Ramp Slope (%)	9.0
Yes	Ramp Width (in)	48.0	Yes	Ramp XSlope (%)	1.4
N/A	Flare Type LT	N/A	N/A	Flare Type RT	N/A
N/A	Flare Slope LT (%)	N/A	N/A	Flare Slope RT (%)	N/A
N/A	Flare Traversable LT?	N/A	N/A	Flare Traversable RT?	N/A
N/A	Landing Length (in)	N/A	N/A	DWS Provided?	N/A
N/A	Landing Width (in)	N/A	N/A	DWS Contrast?	N/A
N/A	Landing Slope (%)	N/A	N/A	DWS Length (in)	N/A
N/A	Landing X Slope (%)	N/A	N/A	DWS Full Width?	N/A
N/A	Landing Curb? (Y/N)	N/A	N/A	DWS Offset (in)	N/A
N/A	Shared Landing?	N/A			
N/A	Gutter Ponding?	N/A	N/A	Gutter Slope (%)	N/A
N/A	Gutter Lip Ht (in)	N/A	N/A	Gutter X Slope (%)	N/A
N/A	Painted X Walk1?	No	N/A	Painted X Walk2?	No
	X Walk 1 Direction	To SE		X Walk 2 Direction	To NE
N/A	X Walk 1 Width (in)	N/A	N/A	X Walk 2 Width (in)	N/A
	X Walk 1 Slope (%)	1.3		X Walk 2 Slope (%)	2.5
	X Walk 1 X Slope (%)	1.5		X Walk 2 X Slope (%)	0.9

Remove & Replace Curb Ramp With Two New Directional Ramps or Equivalent.
