Access Compliance Report
Public Rights-of-Way
(Curb Ramps)

Intersection ID: 23662	Main Street: CARMEL_RD	Cross Street: RED_OAK_LN	Location:	E
ADA ID: B9F0837CB088	Ramp Type: MedianPerp	Initial Pass/Fail: Fail	Overall Compliance: No	Severity Score: 25

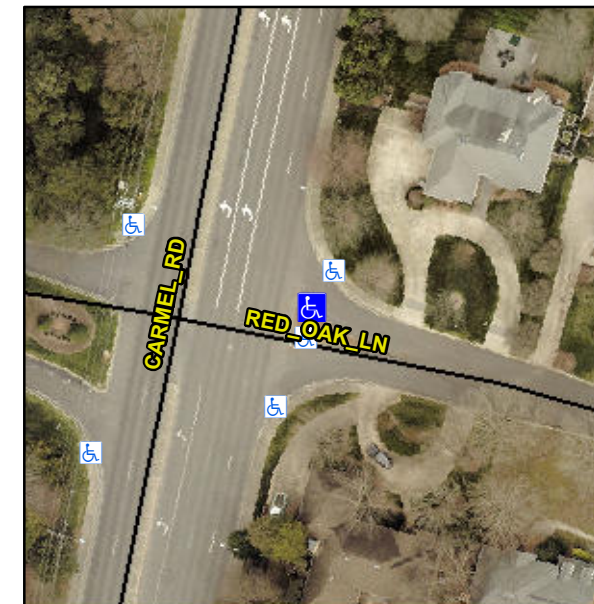
R304.2.2, R304.5.3

Compliance	Description	Data	Compliance	Description	Data
N/A	Ramp Length (in)	57.0	No	Ramp Slope (%)	8.7
Yes	Ramp Width (in)	58.0	No	Ramp XSlope (%)	5.7
N/A	Flare Type LT	N/A	N/A	Flare Type RT	N/A
N/A	Flare Slope LT (%)	N/A	N/A	Flare Slope RT (%)	N/A
N/A	Flare Traversable LT?	N/A	N/A	Flare Traversable RT?	N/A
N/A	Landing Length (in)	N/A	N/A	DWS Provided?	N/A
N/A	Landing Width (in)	N/A	N/A	DWS Contrast?	N/A
N/A	Landing Slope (%)	N/A	N/A	DWS Length (in)	N/A
N/A	Landing X Slope (%)	N/A	N/A	DWS Full Width?	N/A
N/A	Landing Curb? (Y/N)	N/A	N/A	DWS Offset (in)	N/A
N/A	Shared Landing?	N/A			
N/A	Gutter Ponding?	N/A	N/A	Gutter Slope (%)	N/A
N/A	Gutter Lip Ht (in)	N/A	N/A	Gutter X Slope (%)	N/A
N/A	Painted X Walk1?	No	N/A	Painted X Walk2?	N/A
	X Walk 1 Direction	To N		X Walk 2 Direction	N/A
N/A	X Walk 1 Width (in)	N/A	N/A	X Walk 2 Width (in)	N/A
	X Walk 1 Slope (%)	0.6		X Walk 2 Slope (%)	N/A
	X Walk 1 X Slope (%)	5.1		X Walk 2 X Slope (%)	N/A

Remove & Replace Entire Ramp.
