Access Compliance Report
Public Rights-of-Way
(Curb Ramps)

Intersection ID: 29240	Main Street: MALLARD_FOREST_DR	Cross Street: TRIMBACH_WY	Location: SE
ADA ID: BB351471AC0C	Ramp Type: PerpDiag	Initial Pass/Fail: Fail	Overall Compliance: No Severity Score: 13.75

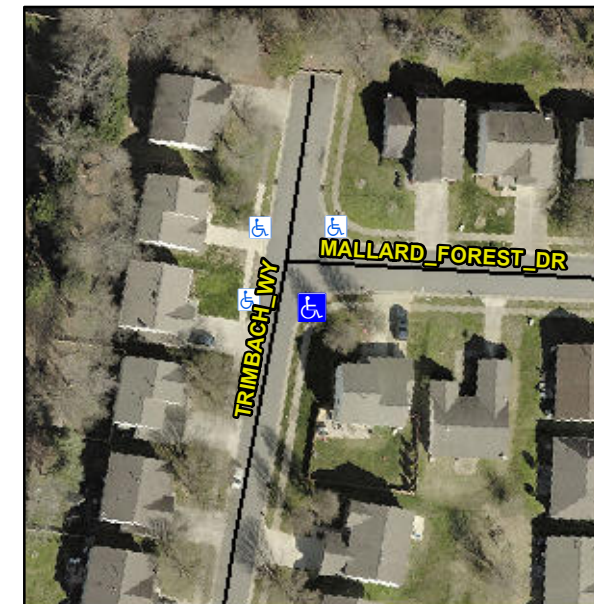
Not Found, R304.2.2, R304.5.3

Compliance	Description	Data	Compliance	Description	Data
N/A	Ramp Length (in)	43.5	No	Ramp Slope (%)	10.5
Yes	Ramp Width (in)	55.0	No	Ramp XSlope (%)	2.4
N/A	Flare Type LT	N/A	N/A	Flare Type RT	N/A
N/A	Flare Slope LT (%)	N/A	N/A	Flare Slope RT (%)	N/A
N/A	Flare Traversable LT?	N/A	N/A	Flare Traversable RT?	N/A
N/A	Landing Length (in)	N/A	N/A	DWS Provided?	N/A
N/A	Landing Width (in)	N/A	N/A	DWS Contrast?	N/A
N/A	Landing Slope (%)	N/A	N/A	DWS Length (in)	N/A
N/A	Landing X Slope (%)	N/A	N/A	DWS Full Width?	N/A
N/A	Landing Curb? (Y/N)	N/A	N/A	DWS Offset (in)	N/A
N/A	Shared Landing?	N/A			
N/A	Gutter Ponding?	N/A	N/A	Gutter Slope (%)	N/A
N/A	Gutter Lip Ht (in)	N/A	N/A	Gutter X Slope (%)	N/A
N/A	Painted X Walk1?	No	N/A	Painted X Walk2?	No
	X Walk 1 Direction	To NE		X Walk 2 Direction	To W
N/A	X Walk 1 Width (in)	N/A	N/A	X Walk 2 Width (in)	N/A
	X Walk 1 Slope (%)	2.4		X Walk 2 Slope (%)	1.8
	X Walk 1 X Slope (%)	0.1		X Walk 2 X Slope (%)	0.7

N/A	Ramp inside XWalk1?	N/A	N/A	Ramp inside XWalk2?	N/A
	Road Slope (%)	0.3	N/A	Clear Space?	N/A
	Road X Slope (%)	2.0	N/A	Clear Space to XWalk (in)	N/A
N/A	Any Obstructions?	N/A	N/A	Storm Grate/Utility Hazard?	N/A
	Obstruction Type			Storm Grate/Utility Type	
N/A					N/A
			Yes	Surface Condition? (G/P)	Good

Remove & Replace Curb Ramp With Two New Directional Ramps or Equivalent.
