Access Compliance Report
Public Rights-of-Way
(Curb Ramps)

Intersection ID: 43503	Main Street: CYPRESS_CT	Cross Street: PRESCOTT_HILL_AV	Location:	NW
ADA ID: BC4DA6CA692C	Ramp Type: PerpDiag	Initial Pass/Fail: Fail	Overall Compliance: No	Severity Score: 22.5

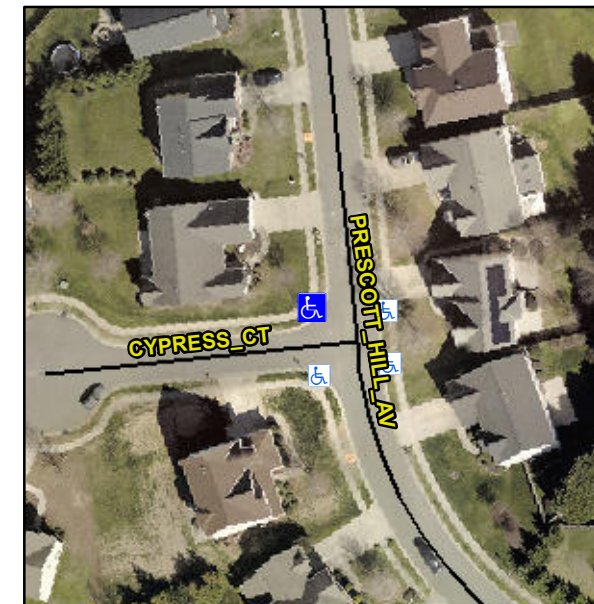
Not Found, R304.5.1, R304.2.2, R304.5.3

Compliance	Description	Data	Compliance	Description	Data
N/A	Ramp Length (in)	46.0	No	Ramp Slope (%)	9.2
No	Ramp Width (in)	44.0	No	Ramp XSlope (%)	2.2
N/A	Flare Type LT	N/A	N/A	Flare Type RT	N/A
N/A	Flare Slope LT (%)	N/A	N/A	Flare Slope RT (%)	N/A
N/A	Flare Traversable LT?	N/A	N/A	Flare Traversable RT?	N/A
N/A	Landing Length (in)	N/A	N/A	DWS Provided?	N/A
N/A	Landing Width (in)	N/A	N/A	DWS Contrast?	N/A
N/A	Landing Slope (%)	N/A	N/A	DWS Length (in)	N/A
N/A	Landing X Slope (%)	N/A	N/A	DWS Full Width?	N/A
N/A	Landing Curb? (Y/N)	N/A	N/A	DWS Offset (in)	N/A
N/A	Shared Landing?	N/A			
N/A	Gutter Ponding?	N/A	N/A	Gutter Slope (%)	N/A
N/A	Gutter Lip Ht (in)	N/A	N/A	Gutter X Slope (%)	N/A
N/A	Painted X Walk1?	No	N/A	Painted X Walk2?	No
	X Walk 1 Direction	To S		X Walk 2 Direction	To E
N/A	X Walk 1 Width (in)	N/A	N/A	X Walk 2 Width (in)	N/A
	X Walk 1 Slope (%)	0.1		X Walk 2 Slope (%)	3.6
	X Walk 1 X Slope (%)	2.6		X Walk 2 X Slope (%)	1.8

N/A	Ramp inside XWalk1?	N/A	N/A	Ramp inside XWalk2?	N/A
	Road Slope (%)	2.5	N/A	Clear Space?	N/A
	Road X Slope (%)	1.2	N/A	Clear Space to XWalk (in)	N/A
N/A	Any Obstructions?	N/A	N/A	Storm Grate/Utility Hazard?	N/A
	Obstruction Type			Storm Grate/Utility Type	
N/A					N/A
			Yes	Surface Condition? (G/P)	Good

Remove & Replace Curb Ramp With Two New Directional Ramps or Equivalent.
