Access Compliance Report
Public Rights-of-Way
(Curb Ramps)

Intersection ID: 10025933 **Main Street:** ELLINGTON_ST **Cross Street:** N/A **Location:** NW

ADA ID: BC5F28E8B75E **Ramp Type:** PerpDiag **Initial Pass/Fail:** Fail **Overall Compliance:** No **Severity Score:** 37.5

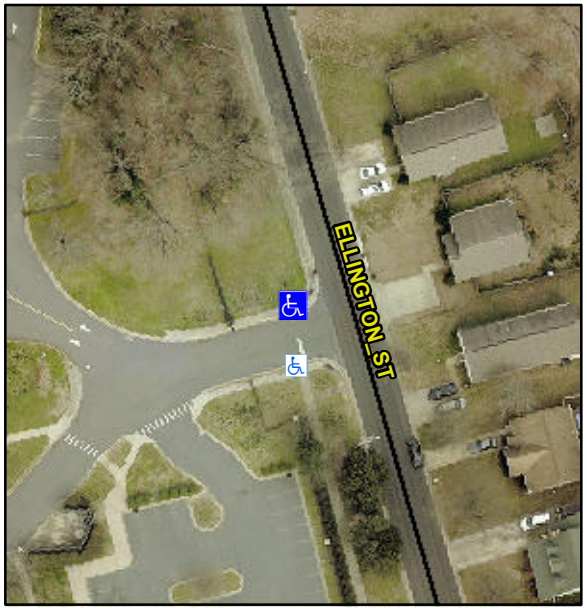
Not Found, R304.2.2, R304.5.3

Compliance	Description	Data	Compliance	Description	Data
N/A	Ramp Length (in)	47.0	No	Ramp Slope (%)	10.1
Yes	Ramp Width (in)	50.0	No	Ramp XSlope (%)	14.4
N/A	Flare Type LT	N/A	N/A	Flare Type RT	N/A
N/A	Flare Slope LT (%)	N/A	N/A	Flare Slope RT (%)	N/A
N/A	Flare Traversable LT?	N/A	N/A	Flare Traversable RT?	N/A
N/A	Landing Length (in)	N/A	N/A	DWS Provided?	N/A
N/A	Landing Width (in)	N/A	N/A	DWS Contrast?	N/A
N/A	Landing Slope (%)	N/A	N/A	DWS Length (in)	N/A
N/A	Landing X Slope (%)	N/A	N/A	DWS Full Width?	N/A
N/A	Landing Curb? (Y/N)	N/A	N/A	DWS Offset (in)	N/A
N/A	Shared Landing?	N/A			
N/A	Gutter Ponding?	N/A	N/A	Gutter Slope (%)	N/A
N/A	Gutter Lip Ht (in)	N/A	N/A	Gutter X Slope (%)	N/A
N/A	Painted X Walk1?	No	N/A	Painted X Walk2?	No
	X Walk 1 Direction	To S		X Walk 2 Direction	To E
N/A	X Walk 1 Width (in)	N/A	N/A	X Walk 2 Width (in)	N/A
	X Walk 1 Slope (%)	3.3		X Walk 2 Slope (%)	1.0
	X Walk 1 X Slope (%)	8.0		X Walk 2 X Slope (%)	6.9

Remove & Replace Curb Ramp With Two New Directional Ramps or Equivalent.
